AGENDA  
PUBLIC FACILITIES COMMITTEE

Date: February 5, 2016

Subject : **Stormwater Inventory & Evaluation  
Plantation Business Park  
Project: 150251**

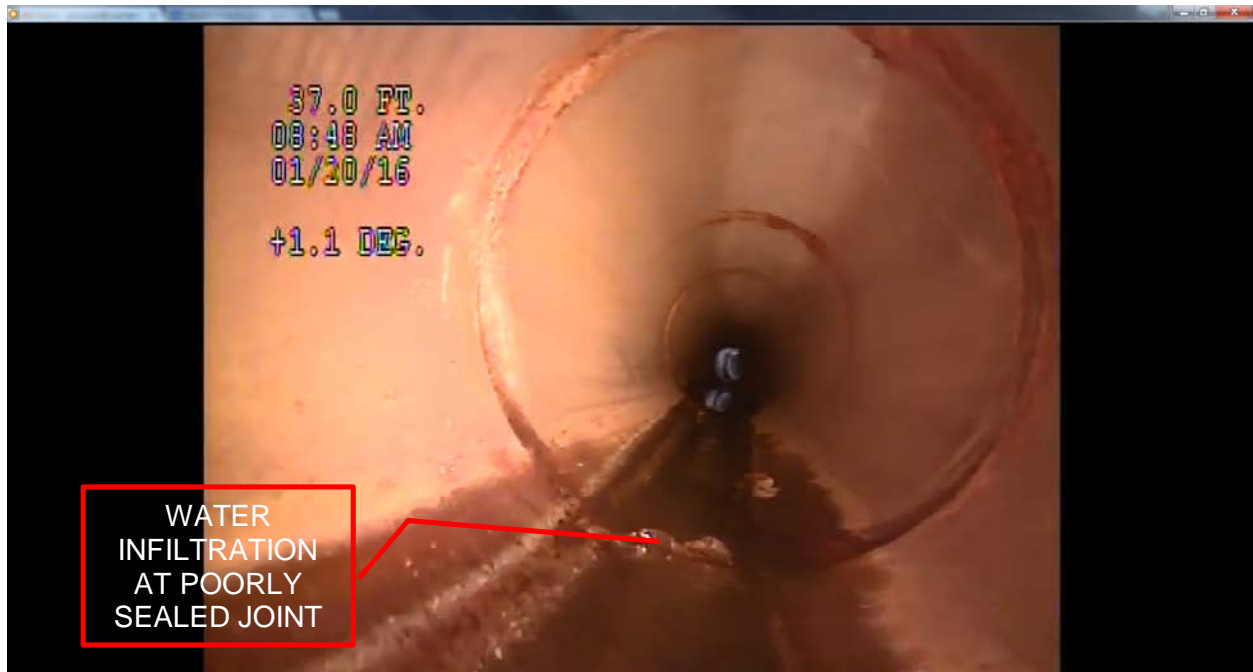
*Figure 7 - Pipe C15-C16: Evidence of water infiltration through pipe joints*

- The concrete pipe sections are generally in fair condition, but there is evidence of some installation problems given the soil infiltration at some joints and some of the poorly plugged lifting eye holes. Structurally, the RCP pipes are functional, but the observed soil infiltration would require more frequent cleaning. Additionally, over time the soil infiltration will result in sink holes and pavement failure in the road. Given that the RCP is located under pavement, removal and replacement would be cost prohibitive. The RCP could be slip lined with a plastic pipe, but this would result in a decrease in the internal diameter and the flow capacity of the pipe. Slip lining 24" RCP would reduce the cross sectional area to the equivalent of an 18" RCP. This is not recommended because it could create upstream drainage problems. The better alternative is cured in place plastic (CIPP) lining. This is more expensive than slip lining but doesn't result in a reduction in flow capacity.

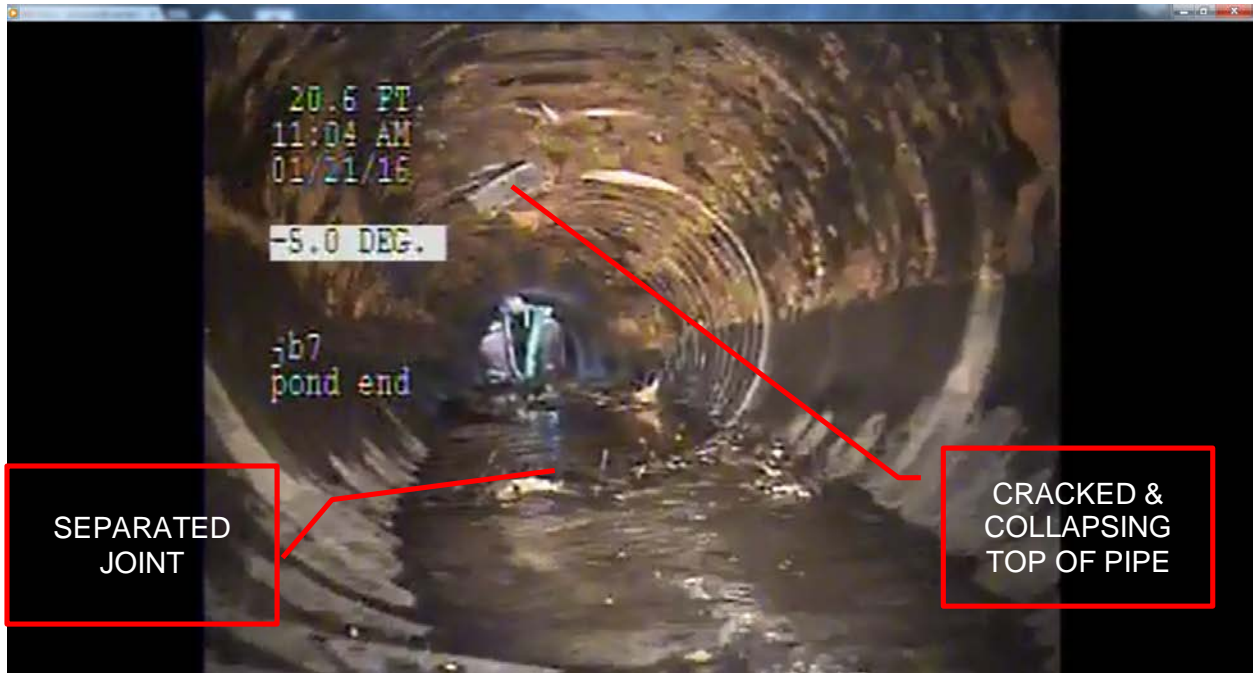
G17-PONDEND HDPE Pipe: This pipe is in very poor condition. Severe deflection is occurring within some sections of the pipe, resulting in large, visible cracks in the inner wall. Deflection is also occurring at some joints, with noticeable gaps in the inner walls. There are frequent buckling occurring along the entire length. Visual estimation of the deflection shows typical vertical deflections around 2" (8%), exceeding the maximum allowed 7.5% deflection. Per SCDOT inspection requirements, pipes with greater than 7.5% of deflection require removal and replacement. These conditions indicate improper handling and installation of the pipe during construction and likely would not be a result of long term settlement or poor maintenance.

*Figure 10: Pipe G17-PONDEND: Severe joint deflection and damage likely resulting during improper installation.*

- The conditions of all of the HDPE pipe sections are so poor that they likely require removal and replacement. Given that the HDPE pipe is located within landscape areas and within drainage easements; excavation, removal, and replacement with new RCP is likely the best option.

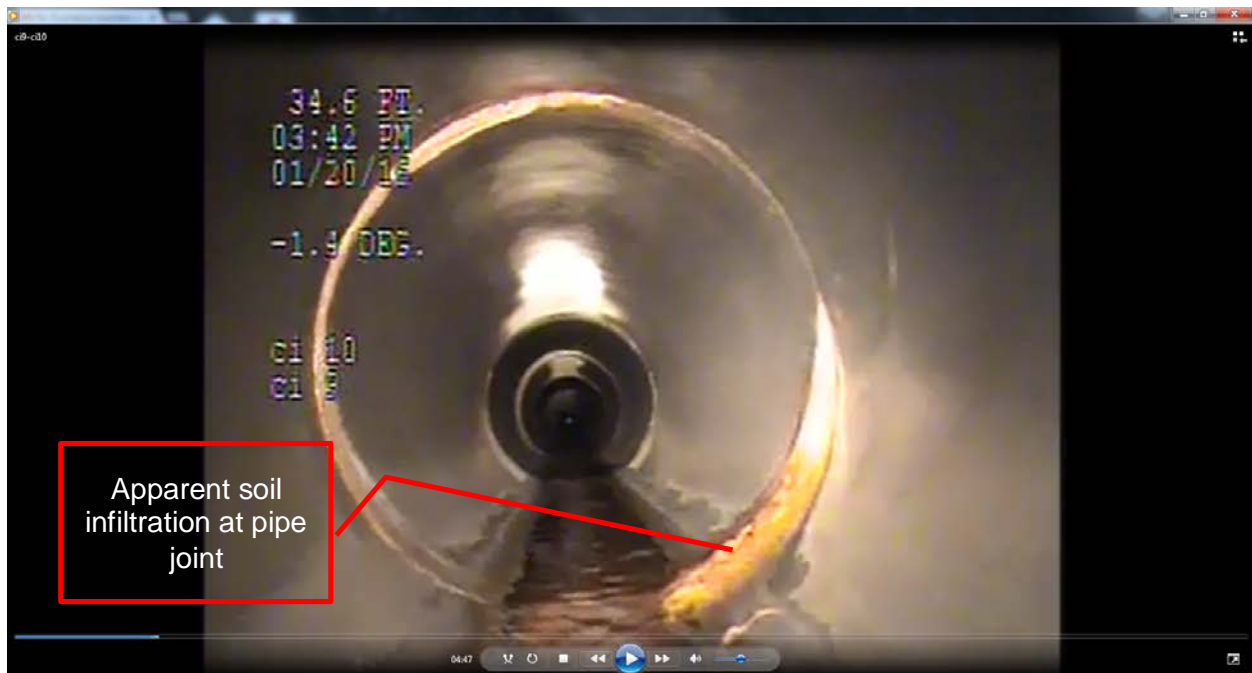
CI9-CI10 Concrete Pipe: This pipe is generally in fair condition. There is apparent soil and root infiltration at the majority of joints, with significant sediment buildup along the lower halves of the joints. This is a possible indication that the joints were not properly wrapped with filter fabric during installation. Some pipes have a hole in the top of the pipe centered along the length of each joint. The holes are stuffed with what appears to be filter fabric. These holes were likely drilled by the contractor and used to hoist the pipes into place via and eye bolt through the hole. The holes were likely plugged with the filter fabric and grouted over on the outside. However, grout on the exterior of the holes can't be verified without excavating over the pipes.

*Figure 13: Pipe CI9-CI10: Sediment accumulation at pipe joint likely from infiltration through joint.*
