AGENDA
PUBLIC FACILITIES COMMITTEE

Topic: Plantation Business Park Documents
Date Submitted: May 15, 2017
Submitted By: Eric Larson
Venue: Public Facilities Committee

Subject : **Stormwater Inventory & Evaluation
Plantation Business Park
Project: 150251**

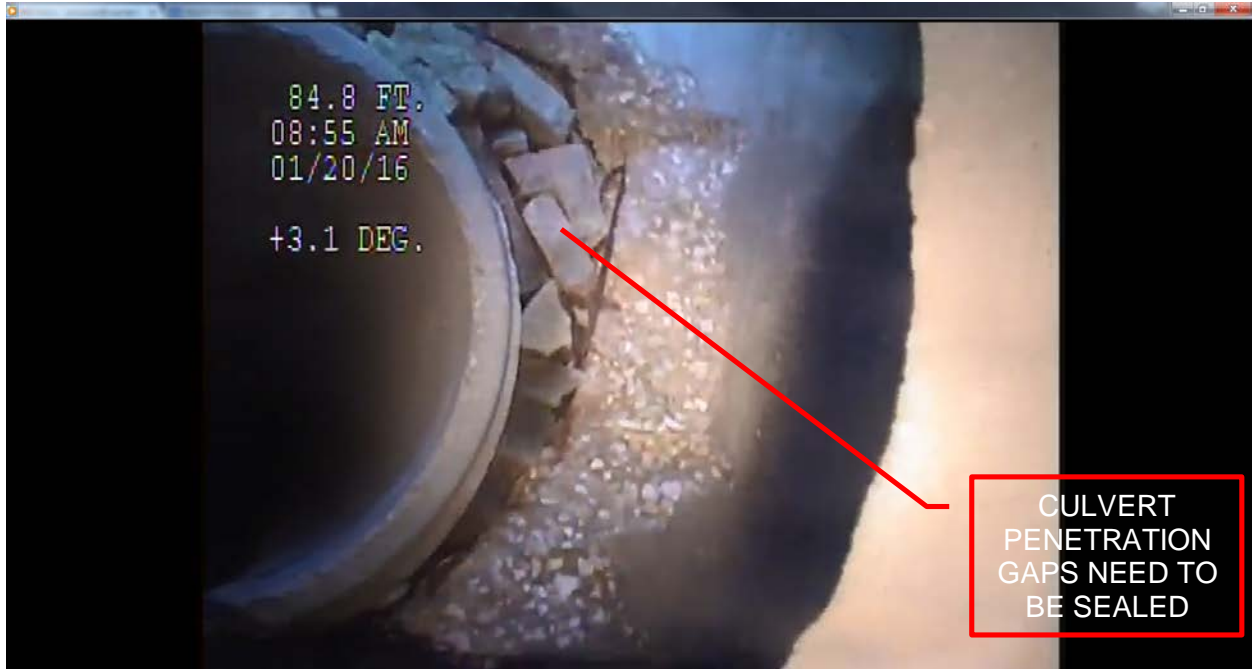
CI-6 - Culvert penetration needs to be sealed.

Figure 1 - Example of culvert penetration needing to be sealed with new grout.

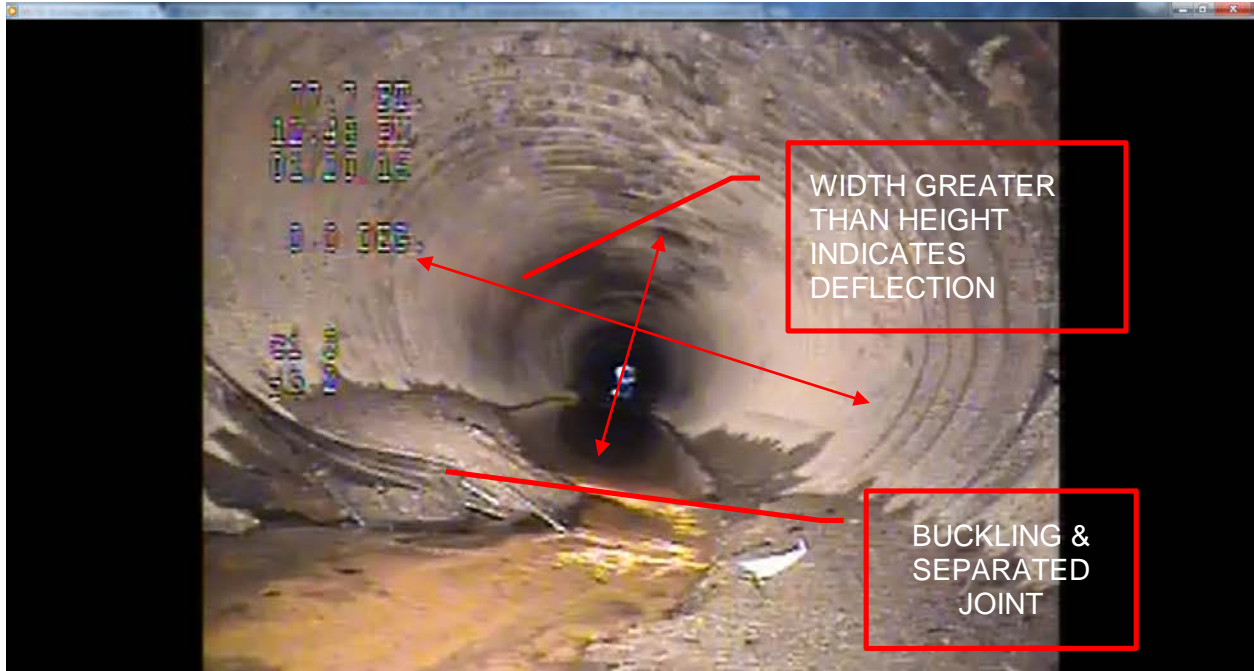
JB2-CI3 HDPE Pipe: This pipe is exhibiting severe deflection/compression, such that the pipe appear elliptical in the inspection video. Visual estimation of the deflection shows typical vertical deflections around 3" (10%), far exceeding the maximum allowed 7.5% deflection. Per SCDOT inspection requirements, pipes with greater than 7.5% of deflection require removal and replacement. Significant root intrusion is occurring within multiple portions of the pipe. Severe deflection is occurring within other sections of the pipe, resulting in large, visible cracks in the inner wall. There are two noticeable punctures within the inner pipe walls as well. These conditions indicate improper handling and installation of the pipe during construction and likely would not be a result of long term settlement or poor maintenance.

Figure 2 – Pipe JB2-C13: Pipe is experiencing sever deflection and joint separation/buckling

- The conditions of all of the HDPE pipe sections are so poor that they likely require removal and replacement. Given that the HDPE pipe is located within landscape areas and within drainage easements; excavation, removal, and replacement with new RCP is likely the best option.

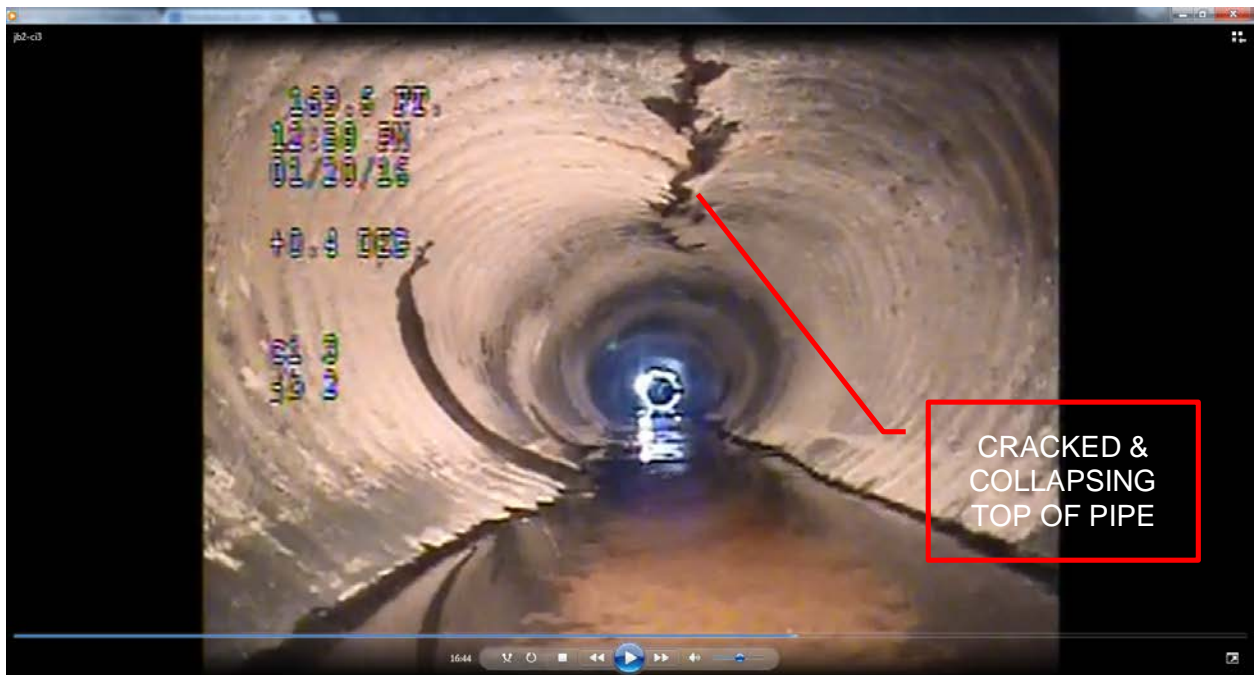
Figure 3 - Pipe JB2-C13: Deflection/buckling is resulting in cracking at the top of the pipe.

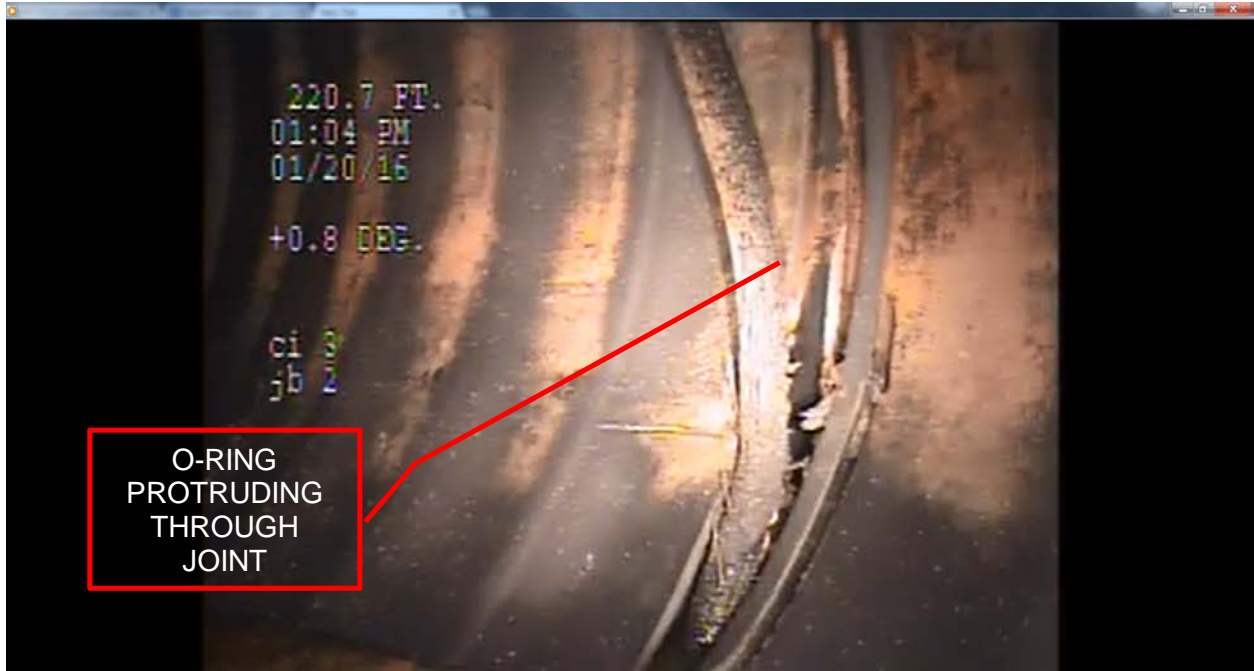
Figure 4 - Pipe JB2-CI3: Example of pipe joint failure with rubber gasket out of place.

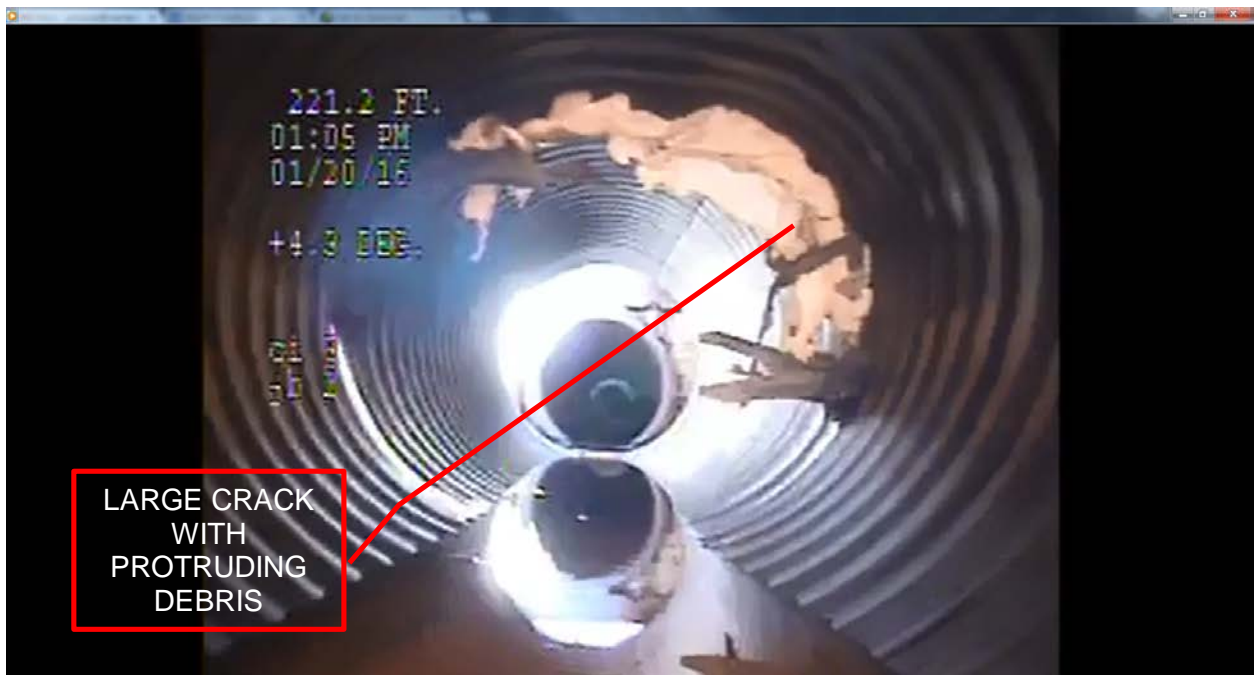
Figure 5 - Pipe JB2-CI3: Large cracks with debris penetration.

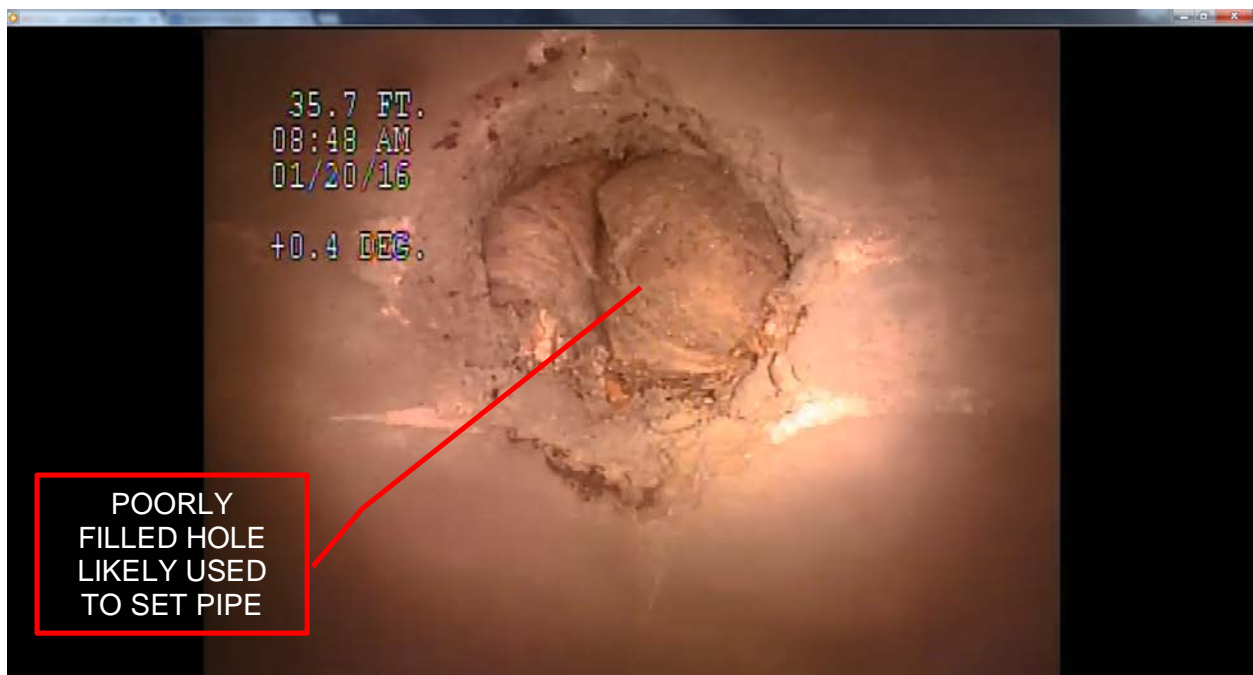
CI5-CI6 Concrete Pipe: This pipe is generally in fair condition. The joints appear to be solid although there is evidence of infiltration at some joints. Each pipe has a hole in the top of the pipe centered along the length of each joint. The holes are stuffed with what appears to be filter fabric. These holes were likely drilled by the contractor and used to hoist the pipes into place via and eye bolt through the hole. The holes were likely plugged with the filter fabric and grouted over on the outside. However, grout on the exterior of the holes can't be verified without excavating over the pipes. A couple of the holes in this pipe show evidence of water seepage and soil infiltration.

Figure 6 - Pipe CI5-CI6: Lifting eye holes plugged with fabric but not properly grouted.

- The concrete pipe sections are generally in fair condition, but there is evidence of some installation problems given the soil infiltration at some joints and some of the poorly plugged lifting eye holes. Structurally, the RCP pipes are functional, but the observed soil infiltration would require more frequent cleaning. Additionally, over time the soil infiltration will result in sink holes and pavement failure in the road. Given that the RCP is located under pavement, removal and replacement would be cost prohibitive. The RCP could be slip lined with a plastic pipe, but this would result in a decrease in the internal diameter and the flow capacity of the pipe. Slip lining 24" RCP would reduce the cross sectional area to the equivalent of an 18" RCP. This is not recommended because it could create upstream drainage problems. The better alternative is cured in place plastic (CIPP) lining. This is more expensive than slip lining but doesn't result in a reduction in flow capacity.

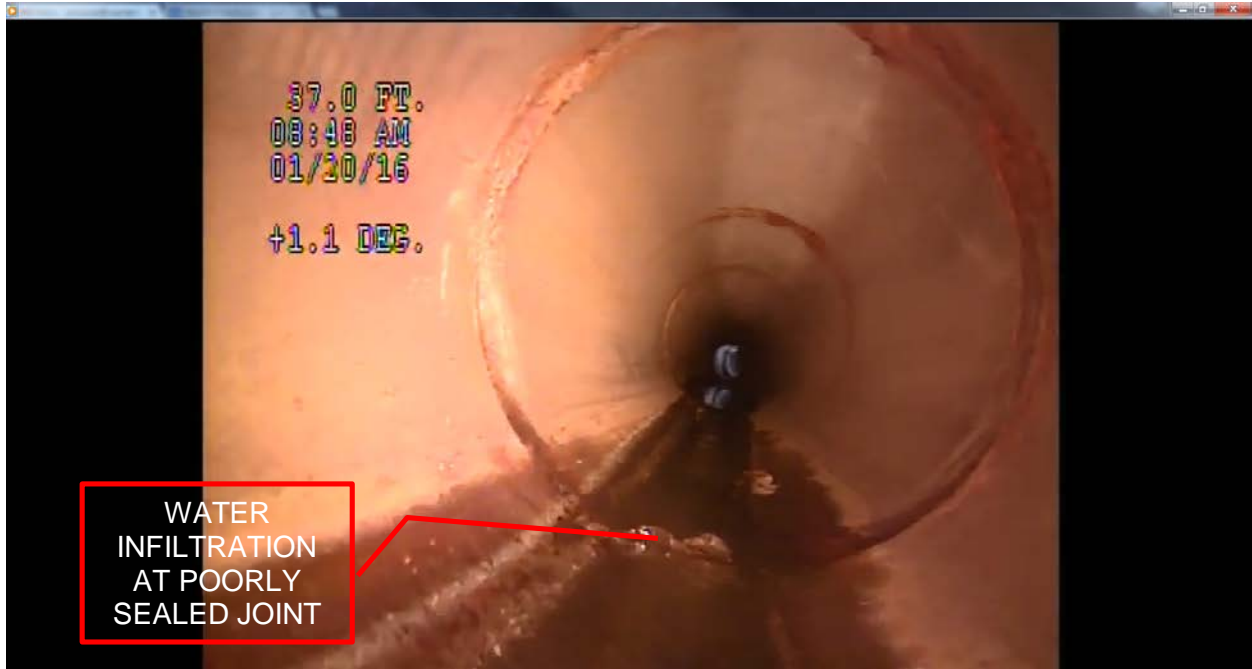
Figure 7 - Pipe C15-C16: Evidence of water infiltration through pipe joints

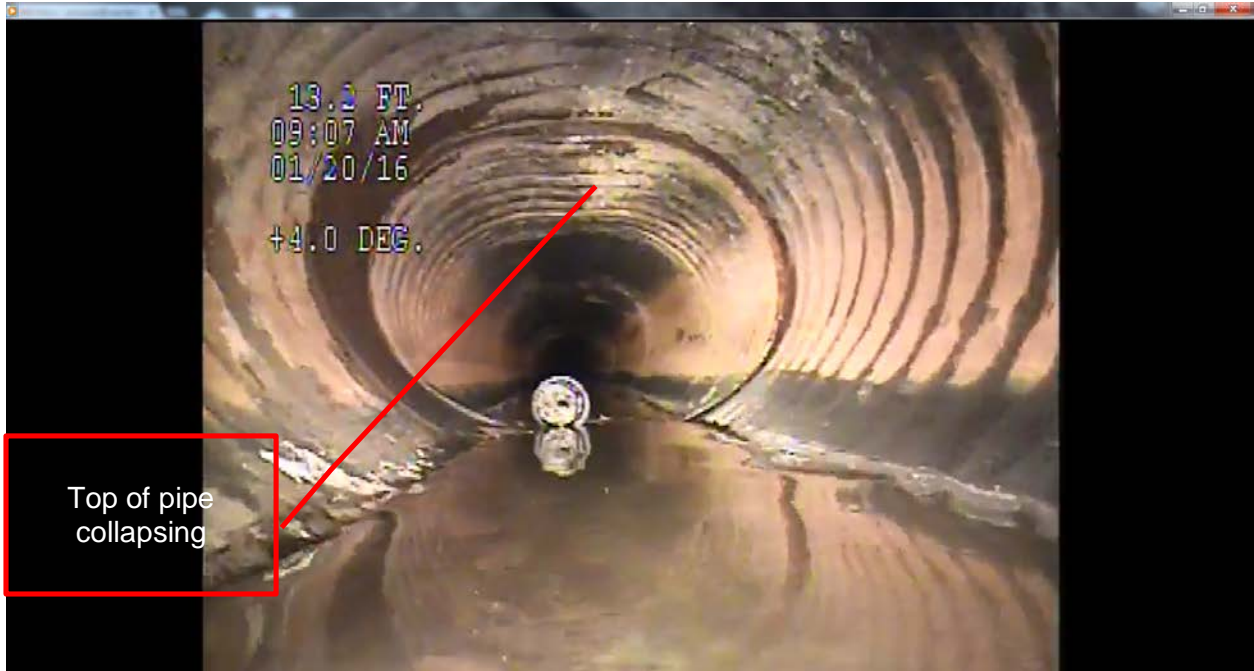
C15-JB2 HDPE Pipe: This pipe is exhibiting severe deflection/compression, such that the pipe appear elliptical in the inspection video. Visual estimation of the deflection shows typical vertical deflections around 3" (10%), far exceeding the maximum allowed 7.5% deflection. Per SCDOT inspection requirements, pipes with greater than 7.5% of deflection require removal and replacement. Significant root intrusion is occurring within multiple portions of the pipe. Severe deflection is occurring within other sections of the pipe, resulting in large, visible cracks in the inner wall. Much of the deflection is occurring at the invert of the pipe section, creating an uneven flowline. These conditions indicate improper handling and installation of the pipe during construction and likely would not be a result of long term settlement or poor maintenance.

Figure 8 - Pipe CI5-JB2: Severe deflection and buckling beyond allowable limits

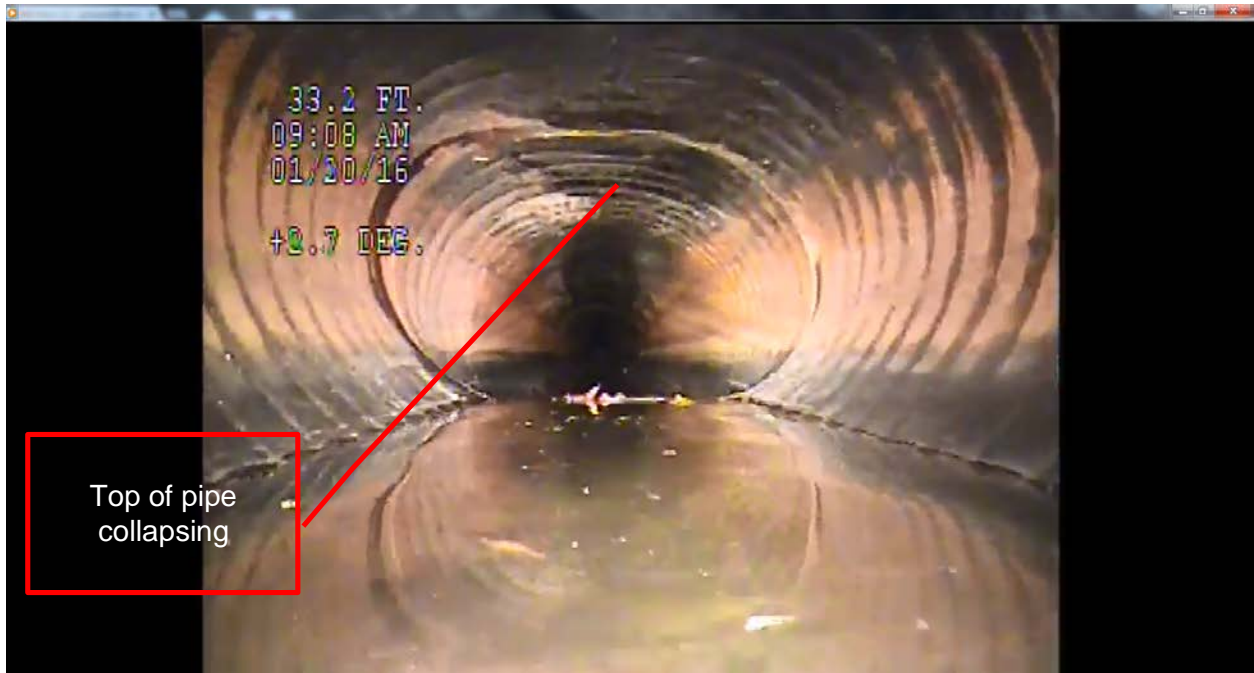
Figure 9: Pipe CI5-JB2: Severe deflection such that pipe is beginning to collapse.

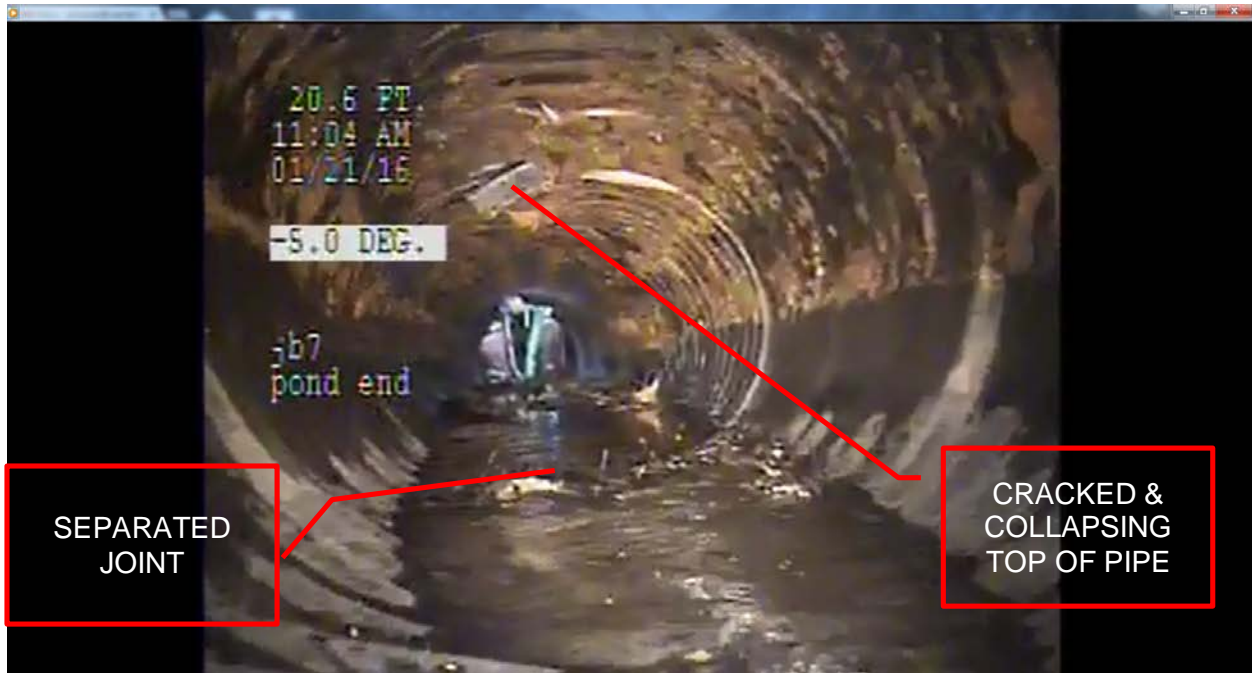
G17-PONDEND HDPE Pipe: This pipe is in very poor condition. Severe deflection is occurring within some sections of the pipe, resulting in large, visible cracks in the inner wall. Deflection is also occurring at some joints, with noticeable gaps in the inner walls. There are frequent buckling occurring along the entire length. Visual estimation of the deflection shows typical vertical deflections around 2" (8%), exceeding the maximum allowed 7.5% deflection. Per SCDOT inspection requirements, pipes with greater than 7.5% of deflection require removal and replacement. These conditions indicate improper handling and installation of the pipe during construction and likely would not be a result of long term settlement or poor maintenance.

Figure 10: Pipe G17-PONDEND: Severe joint deflection and damage likely resulting during improper installation.

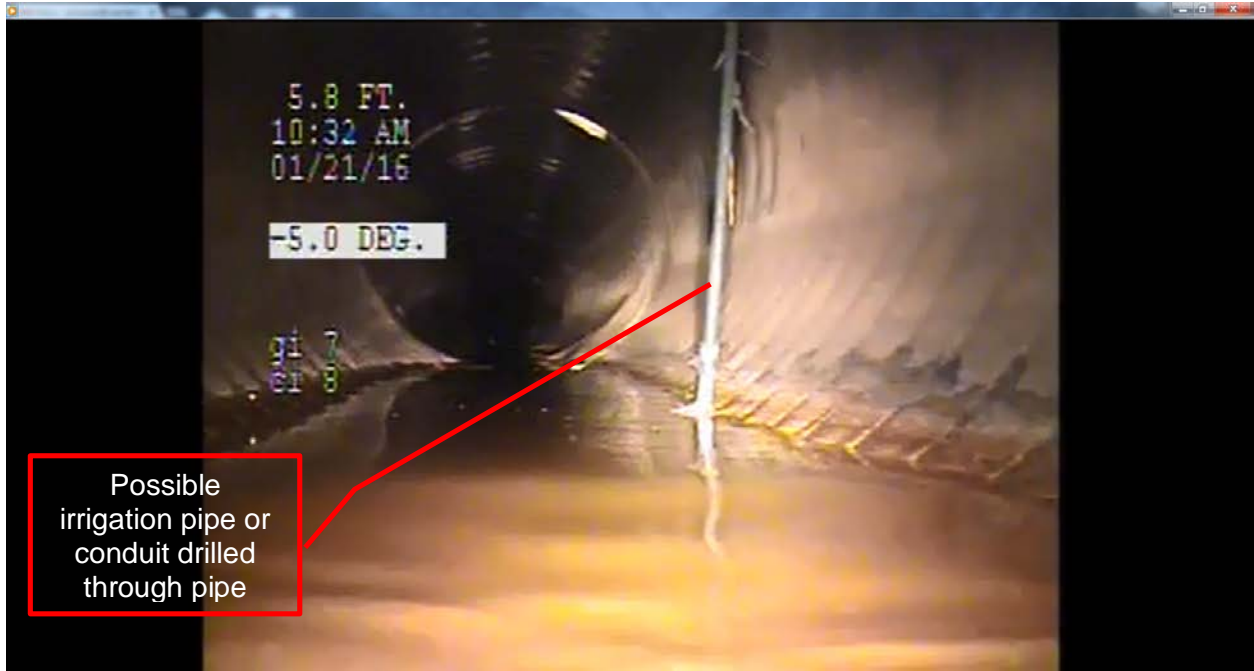
G17-G18 HDPE Pipe: This pipe is in very poor condition. There appears to be some sort of small utility (irrigation or electrical conduit) pipe drilled through the storm pipe. Severe deflection is occurring within some sections of the pipe, resulting in large, visible cracks in the inner wall. Deflection is also occurring at some joints, with noticeable gaps in the inner walls. There are frequent buckling occurring along the entire length, making the invert of the pipe uneven along the length. This would result in flow restriction within the pipe. Visual estimation of the deflection shows typical vertical deflections around 2" (8%), exceeding the maximum allowed 7.5% deflection. Per SCDOT inspection requirements, pipes with greater than 7.5% of deflection require removal and replacement. Significant root intrusion is occurring within multiple portions of the pipe. These conditions indicate improper handling and installation of the pipe during construction and likely would not be a result of long term settlement or poor maintenance.

Figure 11: Pipe GI7-GI8: Irrigation pipe or electrical conduit drilled through pipe.

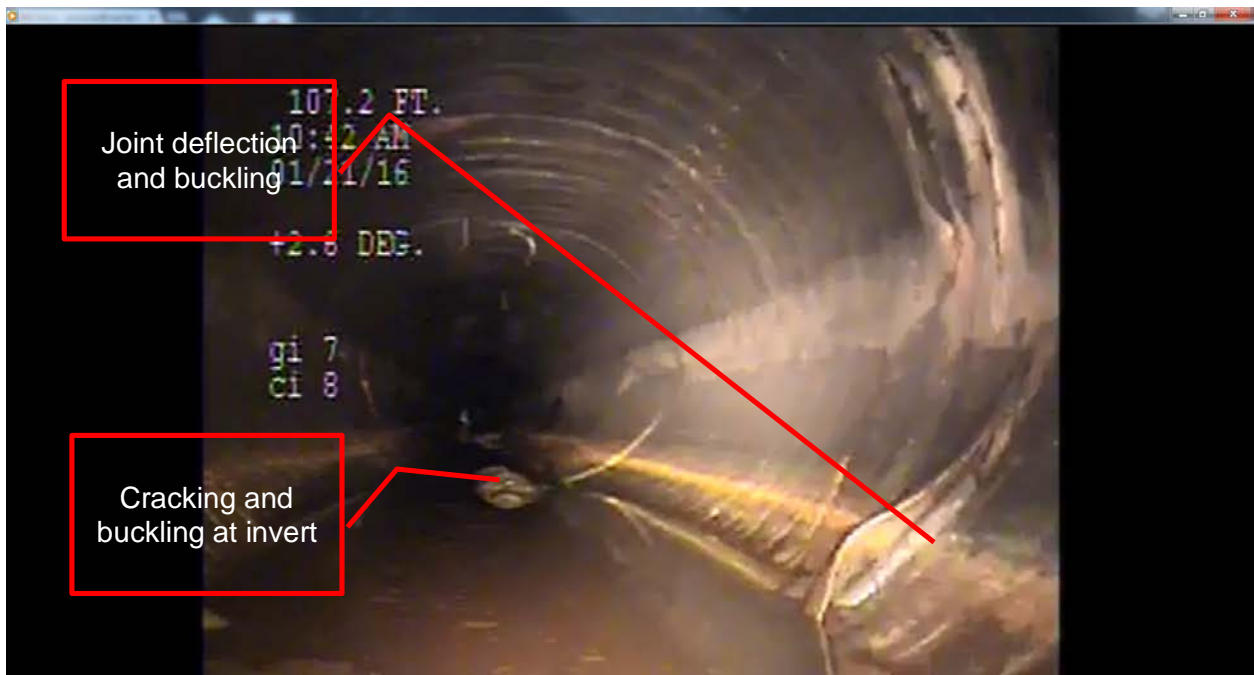
Figure 12: Pipe GI7-GI8: Joint damage likely from improper installation.

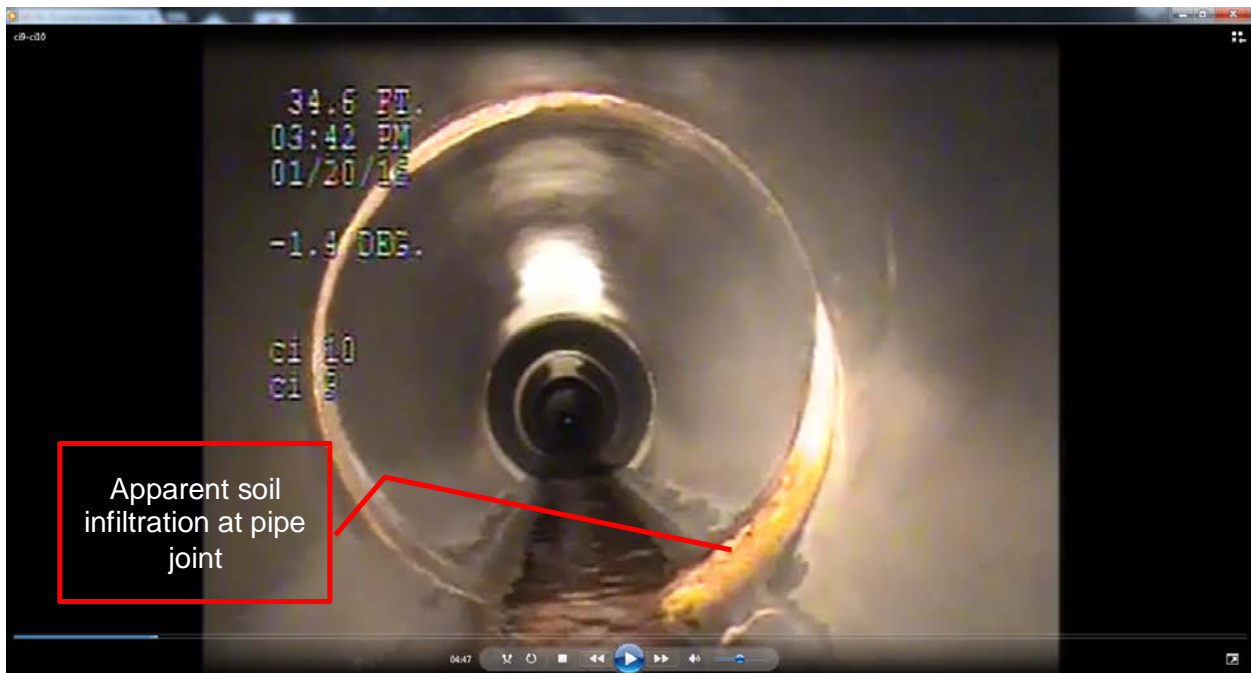
CI9-CI10 Concrete Pipe: This pipe is generally in fair condition. There is apparent soil and root infiltration at the majority of joints, with significant sediment buildup along the lower halves of the joints. This is a possible indication that the joints were not properly wrapped with filter fabric during installation. Some pipes have a hole in the top of the pipe centered along the length of each joint. The holes are stuffed with what appears to be filter fabric. These holes were likely drilled by the contractor and used to hoist the pipes into place via and eye bolt through the hole. The holes were likely plugged with the filter fabric and grouted over on the outside. However, grout on the exterior of the holes can't be verified without excavating over the pipes.

Figure 13: Pipe CI9-CI10: Sediment accumulation at pipe joint likely from infiltration through joint.
