Beaufort County
Public Works
Stormwater Infrastructure
Project Summary

Project Summary: Sheldon Washout Repair - Backache Acres

Project #: 2014-516

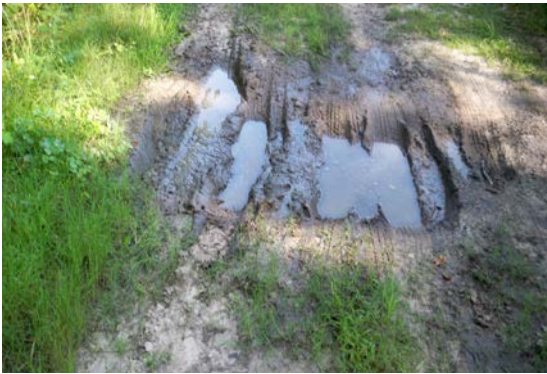
Before

Repaired washout.
