**Beaufort County**  
**Public Works**  
**Stormwater Infrastructure**  
*Project Summary*

**Project Summary:** Blacksmith Circle

**Activity:** Routine/Preventive Maintenance

**Project #:  
2013-593**

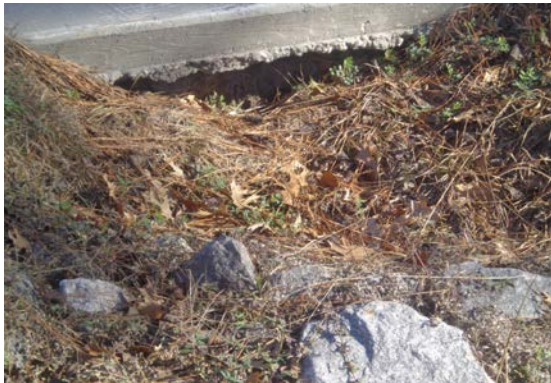
**Before**

Repaired (2) washouts.
