Beaufort County
Public Works
Stormwater Infrastructure
Project Summary

Project Summary: Lost Island Road

Activity: Routine/Preventive Maintenance

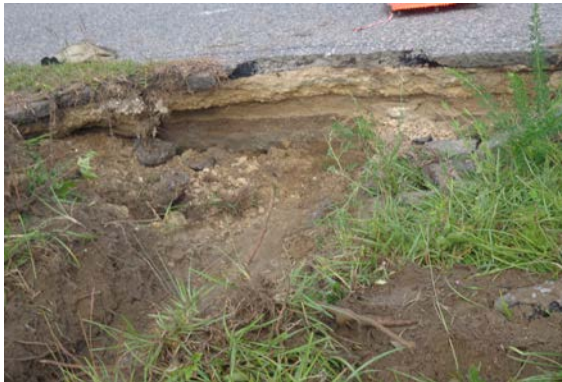
Before

Repaired washout.
