Beaufort County Public Works Stormwater Infrastructure Project Summary

Project Summary: Sea Island Parkway Outfall

Activity: Preventive Maintenance

Project #: 2013-582

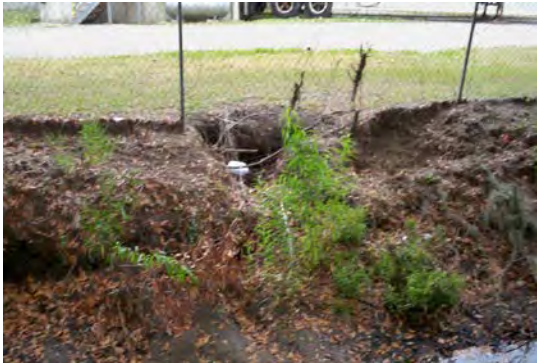
Before

Repaired washout. Installed rip rap for erosion.
