Beaufort County Public Works

Stormwater Infrastructure

Project Summary: Ardmore Avenue

Activity: Routine/Preventive Maintenance

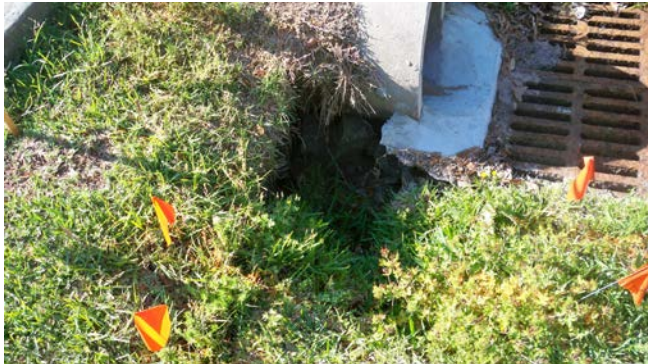
Before

Repaired sinkhole.
