# Beaufort County Public Works Stormwater Infrastructure Project Summary

**Project Summary:** Buckwalter Parkway

**Activity:** Routine/Preventive Maintenance

Project #:  
2014-558

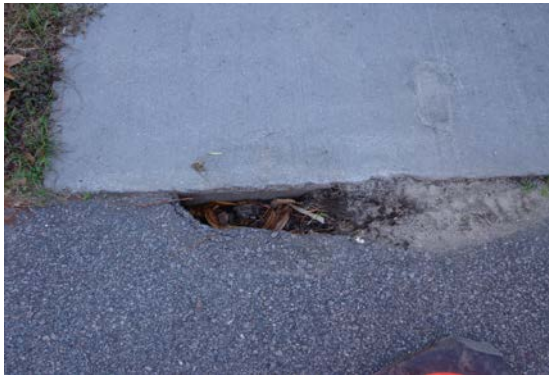
Before

Repaired (2) catch basins and sinkholes.
