Beaufort County Public Works Stormwater Infrastructure

Project Summary: Parkside Drive

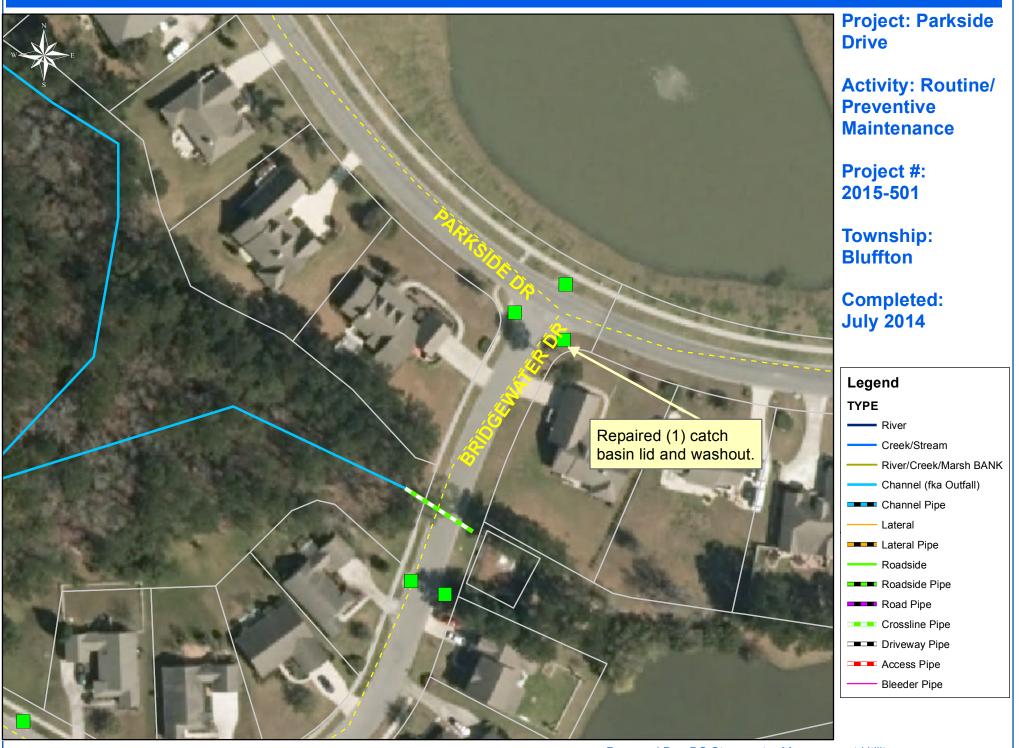
Before

Repaired (1) catch basin lid and washout.
