Beaufort County Public Works

Stormwater Infrastructure

Project Summary: Pin Oak Street/Able Street

Activity: Routine/Preventive Maintenance

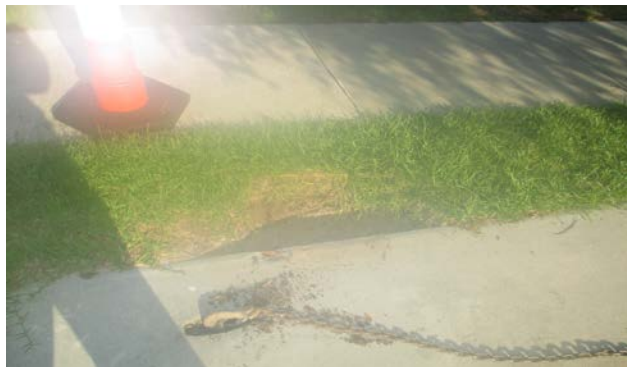
Before

Repaired curb inlet and sinkholes.
