Beaufort County
Public Works
Stormwater Infrastructure
Project Summary

Project Summary: Ardmore Avenue - Rework

Activity: Routine/Preventive Maintenance

**Project #:
2014-620R**

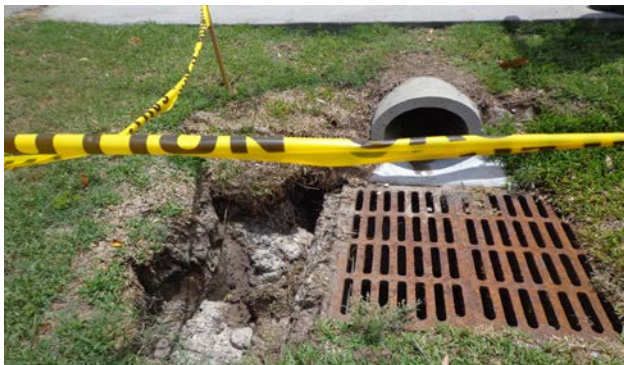
Before

Cleaned out (1) catch basin. Repaired catch basin and sinkhole.
