Beaufort County Public Works Stormwater Infrastructure Project Summary

Project Summary: Pinewood Circle

Activity: Routine/Preventive Maintenance

Project #: 2015-599

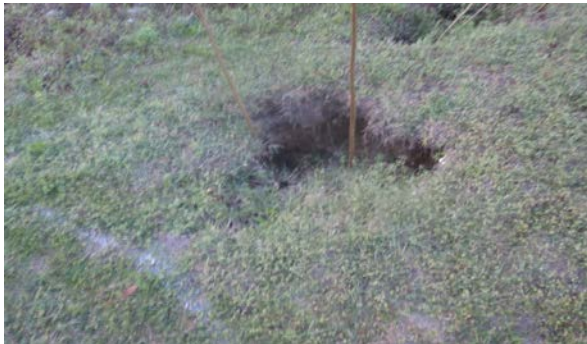
Before

Repaired (1) catch basin and separated joint. Installed rip rap and hydroseeded for erosion control.
