**Beaufort County**  
**Public Works**  
**Stormwater Infrastructure**  
*Project Summary*

**Project Summary:** Eastern Road Channel - Rework

**Activity:** Routine/Preventive Maintenance

**Project #: 2015-011R**

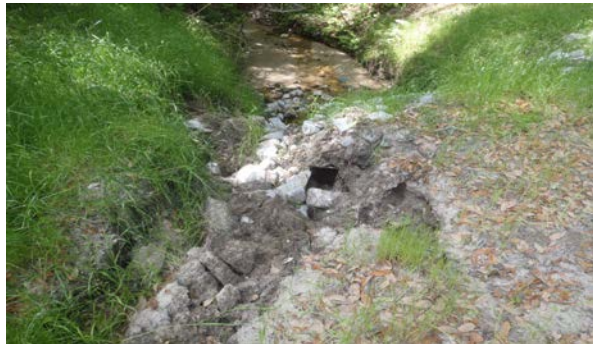
Before

Repaired washout.
