Beaufort County
Public Works
Stormwater Infrastructure
Project Summary

Project Summary: Clydesdale Circle

Activity: Routine/Preventive Maintenance

Project #: 2015-561

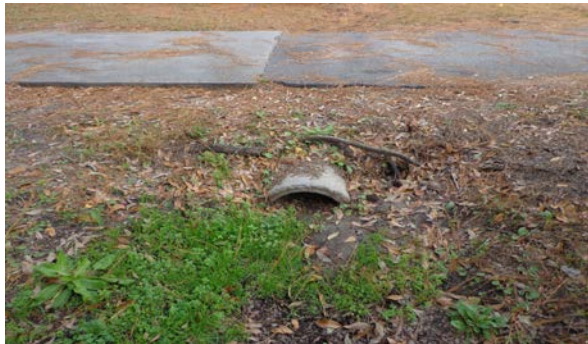
Before

Jetted (1) driveway pipe.
