Beaufort County Public Works Stormwater Infrastructure Project Summary

Project Summary: View Point Circle

Activity: Routine/Preventive Maintenance

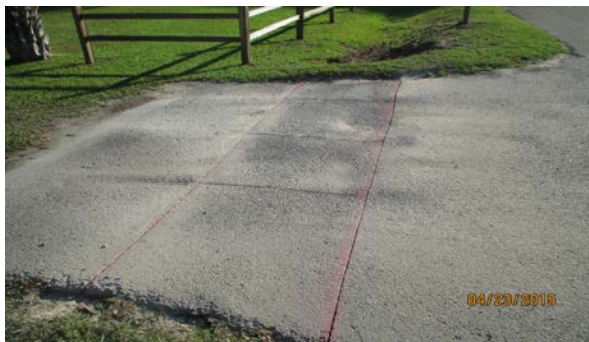
Before

Replaced (1) driveway pipe.
