Beaufort County
Public Works
Stormwater Infrastructure
Project Summary

Project Summary: Oak View Drive Channel #1

Activity: Routine/Preventive Maintenance

**Project #:
2015-614**

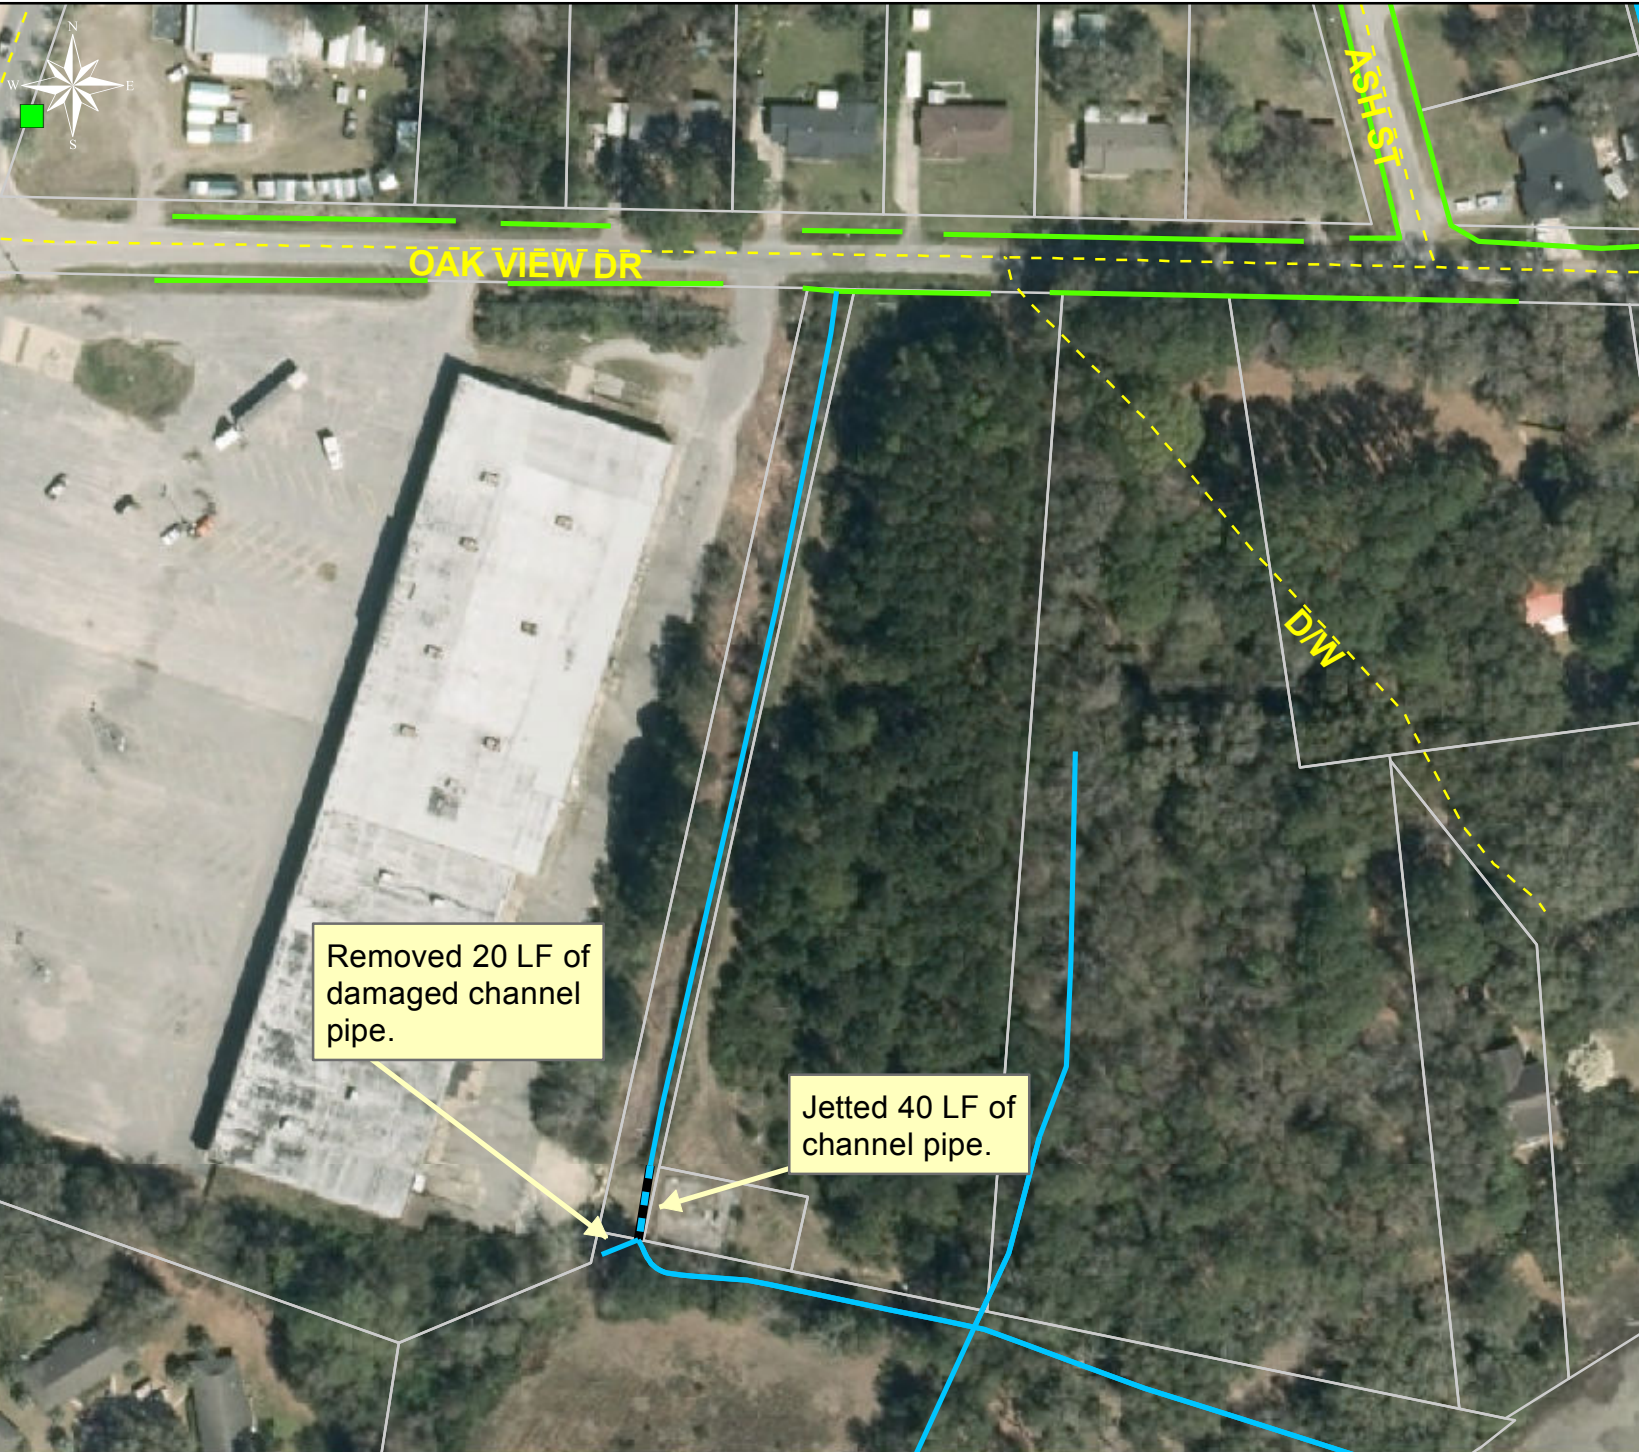
**Project: Oak View
Drive Channel #1
Map 2**

Removed 20 LF of
damaged channel
pipe.

Jetted 40 LF of
channel pipe.
