**Beaufort County**  
**Public Works**  
**Stormwater Infrastructure**  
*Project Summary*

**Project Summary:** Pinewood Circle Channel #1

**Activity:** Routine/Preventive Maintenance

**Project #:  
2015-571**

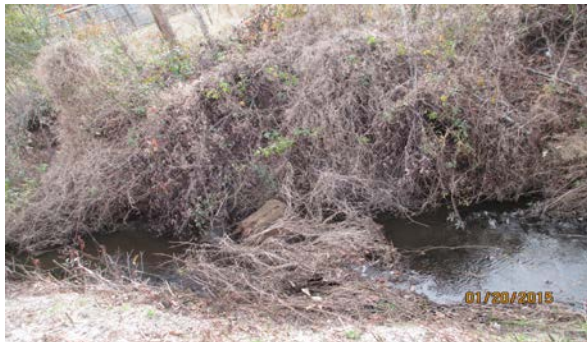
Before

Removed blockages from flowline. Repaired washout.
