**Beaufort County**  
**Public Works**  
**Stormwater Infrastructure**  
*Project Summary*

**Project Summary:** Mint Farm Subdivision Pond

**Activity:** Routine/Preventive Maintenance

Project #: 2015-321

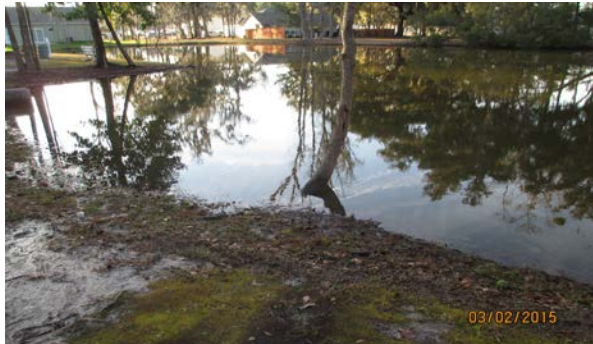
Before

Dewatered pond to safe elevation.
