Beaufort County Public Works Stormwater Infrastructure

Project Summary: Sheldon Washout Repair Huspah Ct S, Jasmine Hall Road

Activity: Routine/Preventive Maintenance Duration: 02/06/19-03/18/19

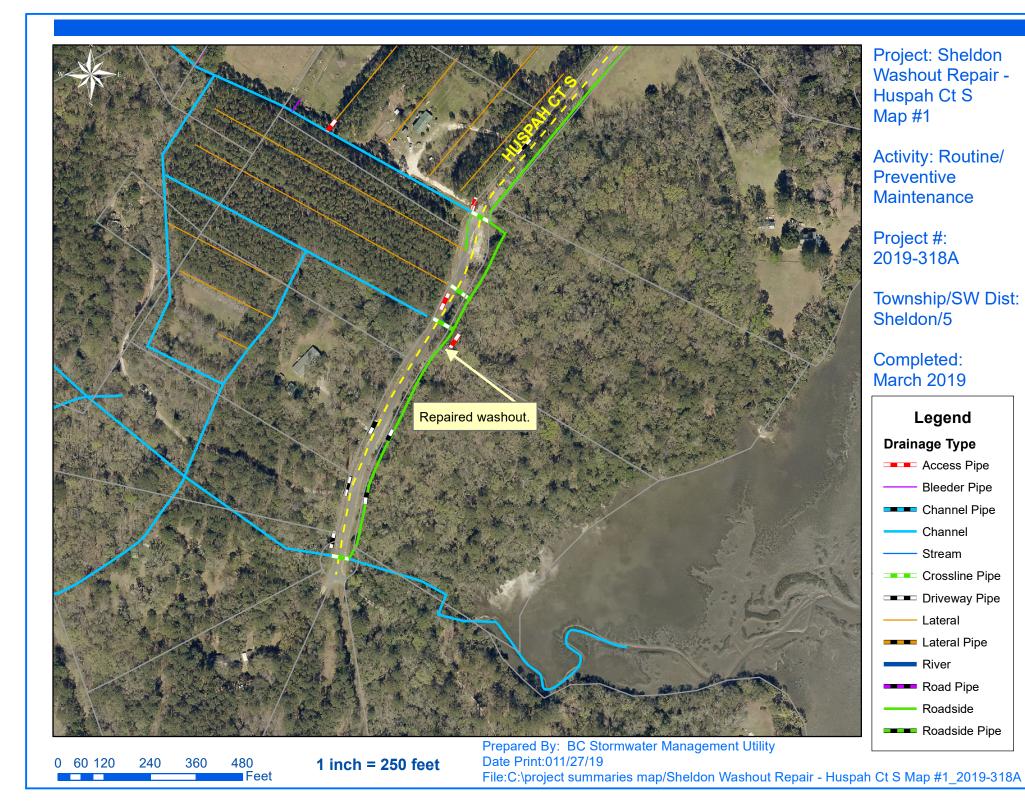
Before

Installed (1) access pipe. Repaired washouts.
