## Beaufort County Public Works Stormwater Infrastructure

**Project Summary**

**Project Summary:** Seigler Road Channel #2

**Activity:** Routine/Preventive Maintenance

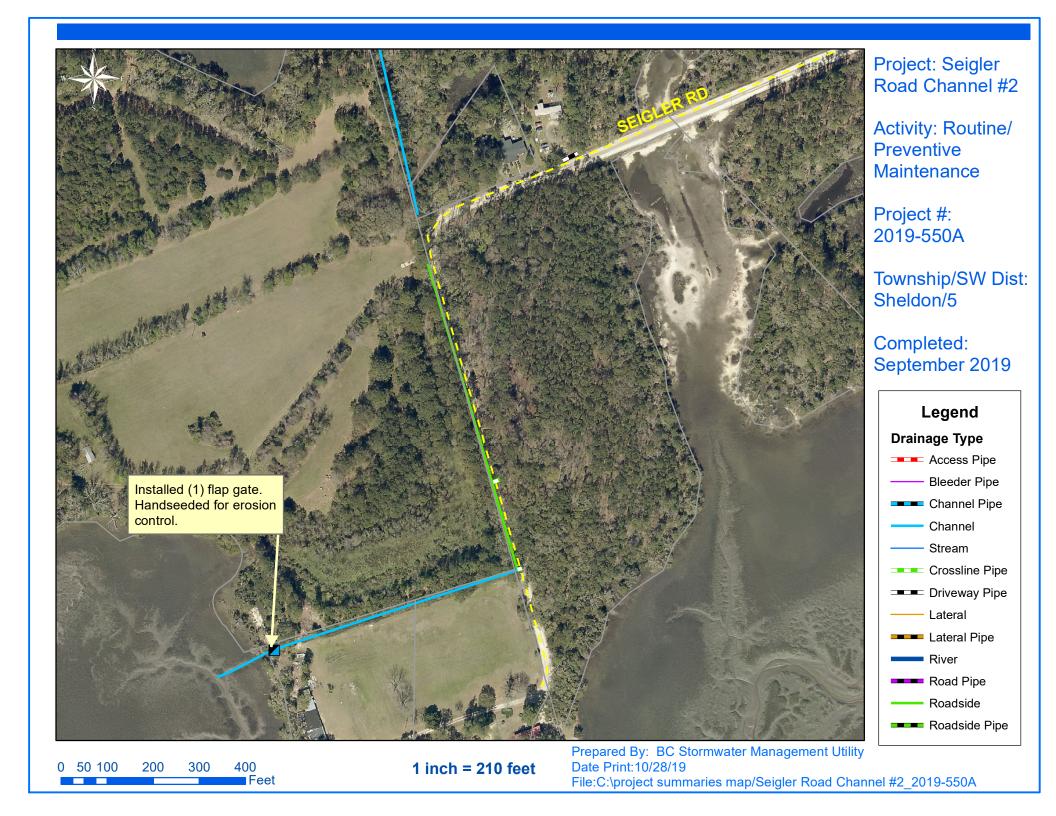
Installed (1) flap gate. Handseeded for erosion control.
