**FOUR WATERS  
ENGINEERING**

**MEMORANDUM**

**RE:** Drainage Analysis for McTeer Drive Ditch at Avenue of Oaks and Waldon Property

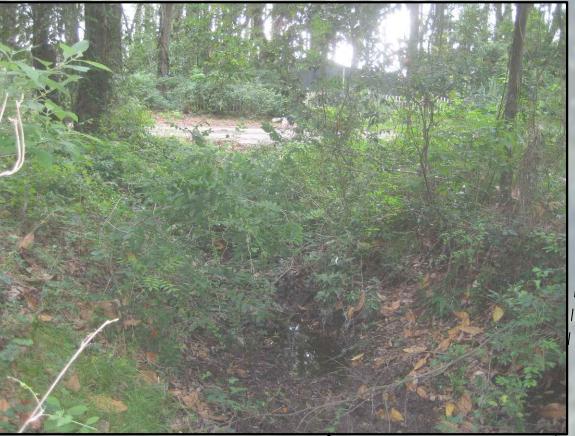
- The water elevation estimated at 7.2' just upstream of McTeer Drive indicates that the ditch is draining but considering standing water present and water marks from the rain event 36 hours ago the ditch is draining at a slow rate.

DITCH WITH MINOR STANDING WATER.  
ESTIMATED WATER ELEV. =7.2'

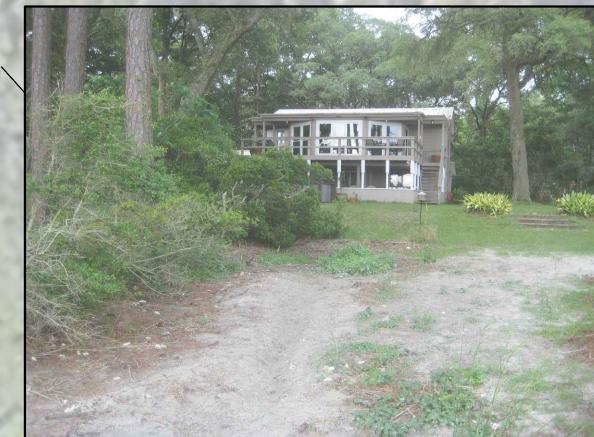
NO STANDING WATER AT  
DITCH ON SITE VISIT  
5/19/2016

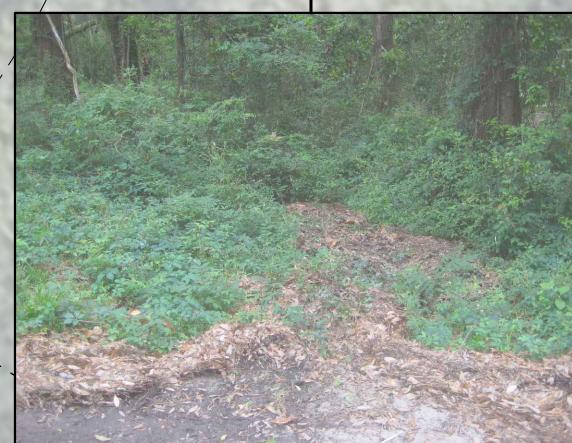
- Based on amount of debris and silt at the McTeer Drive culvert indicates this pipe has not been in full operation for several years.
- Estimated upstream elevations and standing water indicate that the ditch is draining to the northeast. It is evident from property owners and conducted site visits that the water flows in the northeast direction towards McTeer Drive and to the St. Helena Sound.

EDGE OF McTEER DRIVE WITH  
SILT AND DEBRIS

- Improve drainage system to allow for a minimum of 2-yr, 24-hr, design storm peak flows.
- Remove all debris throughout the ditch, specifically the dirt filled in at the ditch at Parcel 222J.
- Replace and raise the culvert across McTeer Drive with design invert elevations that provide positive drainage of the ditch.
- Remove or abandon 24" CMP and replace with new HDPE outfall pipe(s) with higher invert elevations to allow drainage of the ditch, limit tidal tailwater influence, ease permitting, and to avoid extension of the outfall pipe to an existing grade that is more visible near the St. Helena Sound.
- Install rip-rap on filter fabric at the outfall pipe(s) with rip-rap check dams to dissipate stormwater flow energy for erosion control prior to the St. Helena Sound.

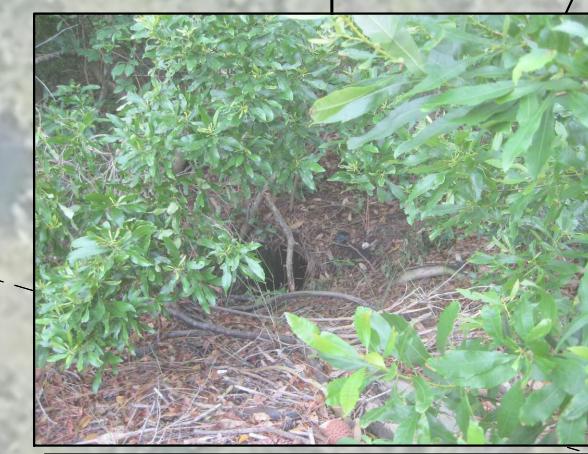
- 24" CMP at the outfall is half buried and invert elevations indicate the pipe is too low and not effective for draining the ditch.
- Culvert under McTeer Drive that connects the upstream ditch to the southwest to the downstream ditch to the northeast was buried and located by Beaufort County. The culvert is an 18" RCP that is filled with debris and silt.

OUTFALL 24" CMP HALF FULL OF DEBRIS
