**To:** Colin Kinton, PE – Beaufort County, SC  
**From:** Mark Lenters – Ourston, and Joe M. Garcia, PE – Ourston  
**Subject:** Bluffton Parkway at Bluffton Road (SC 46)  
Roundabout In-Service Review  
**Date:** February 15, 2018

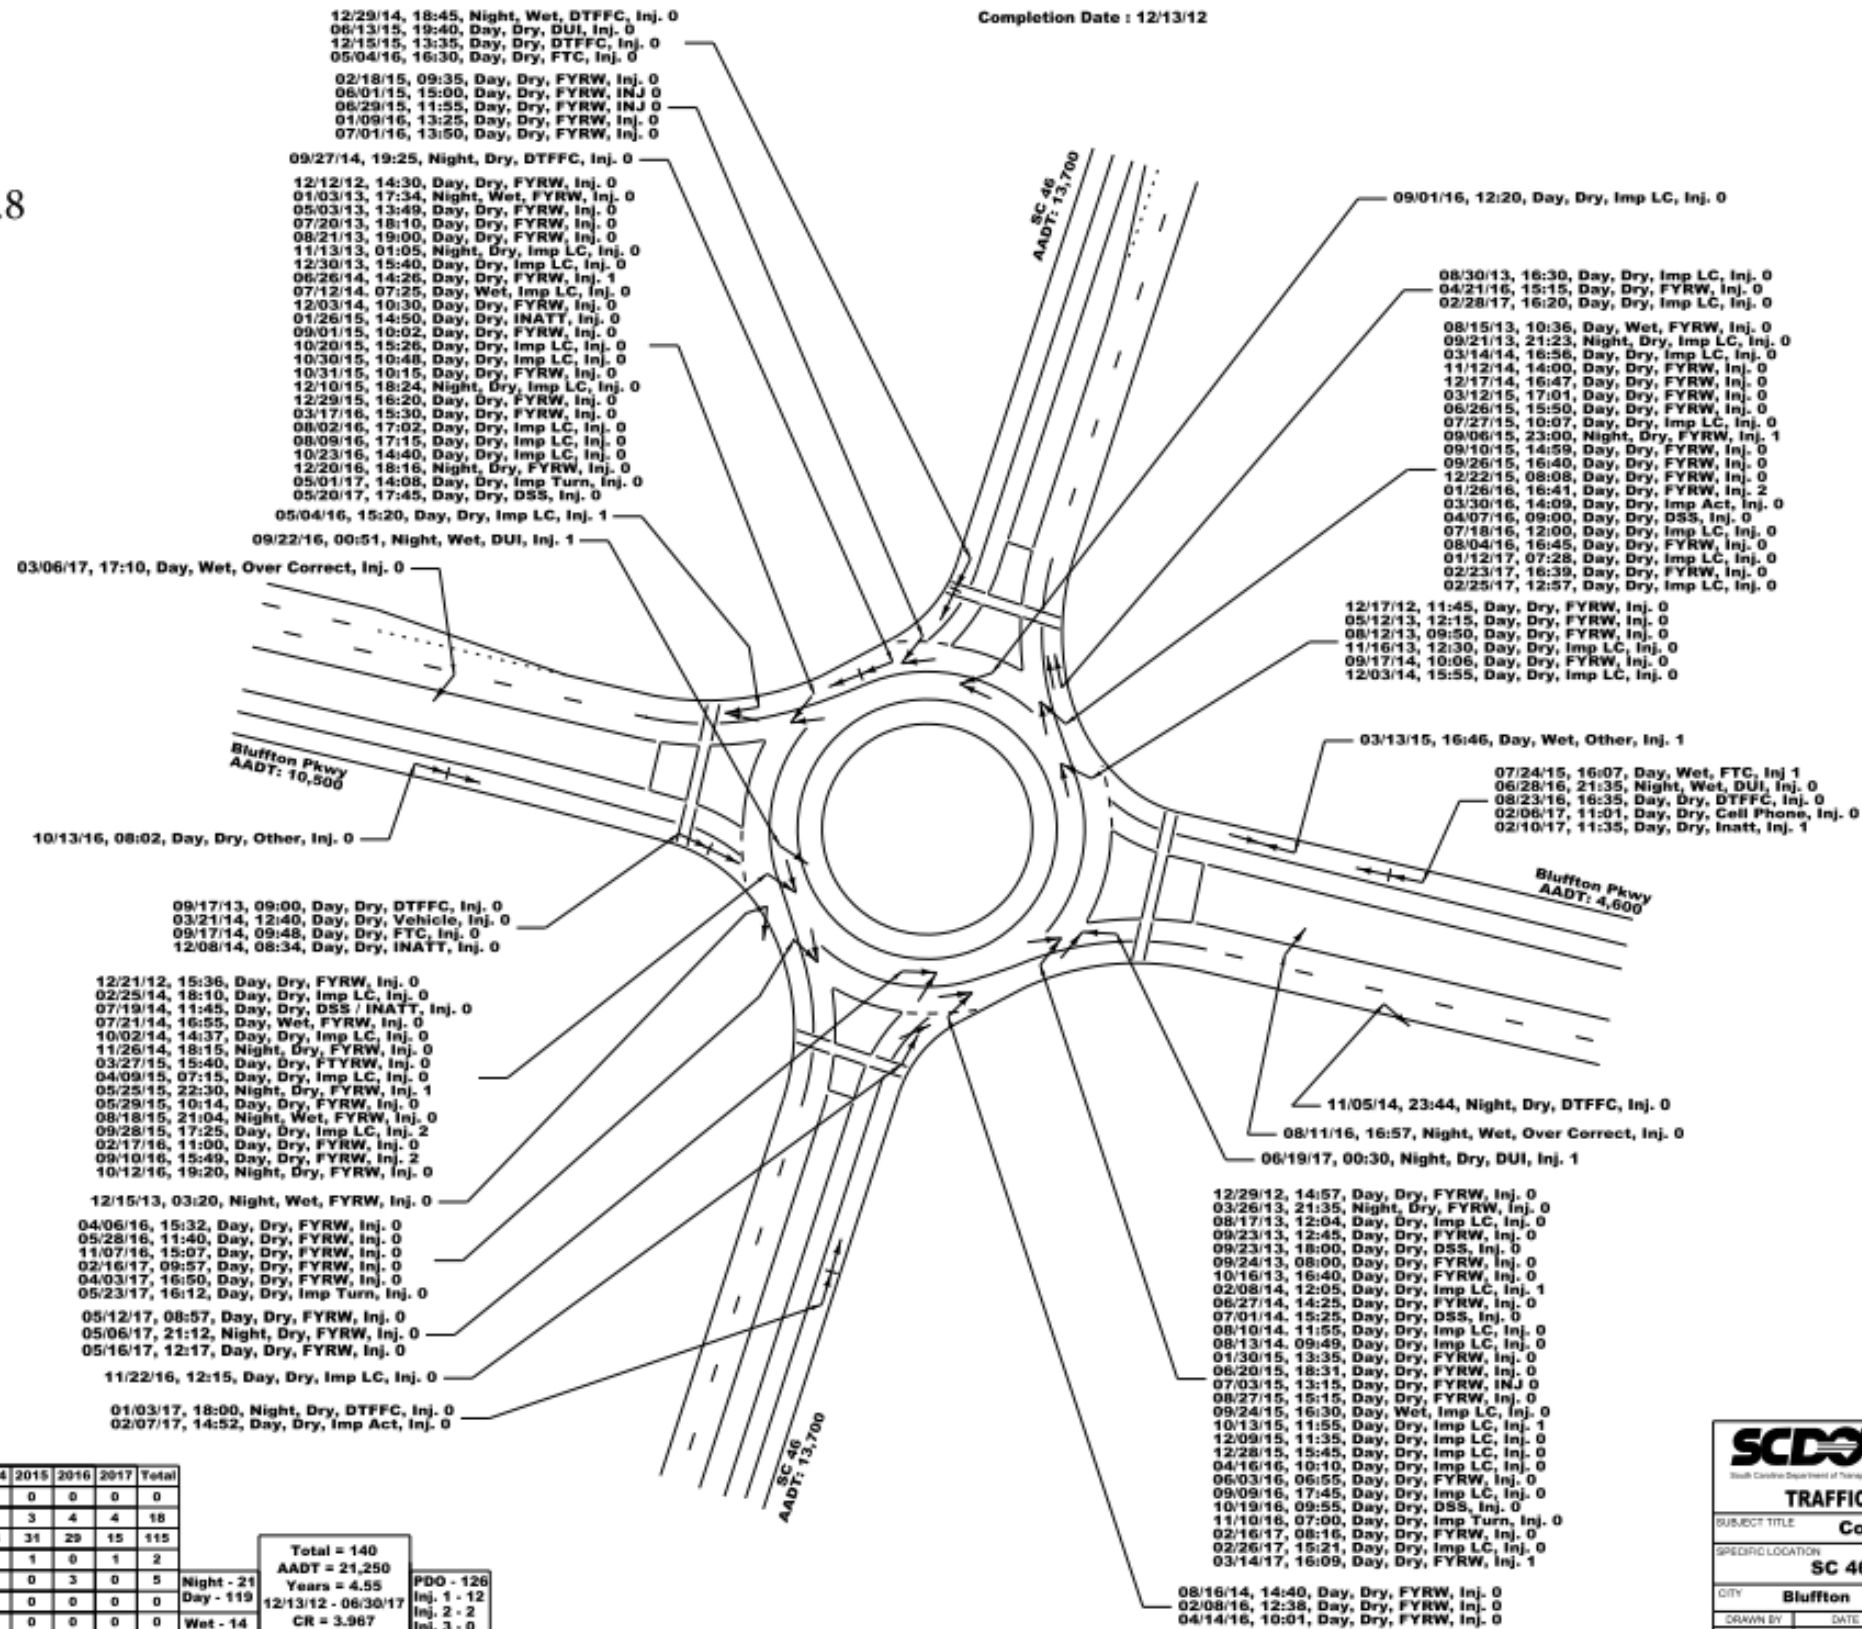
Exhibit: 1.0

Total = 140  
AADT = 21,250  
Years = 4.55  
12/13/12 - 06/30/17  
CR = 3.967  
SI = 4.78

PDO - 126  
Inj. 1 - 12  
Inj. 2 - 2  
Inj. 3 - 0  
Fatal - 0

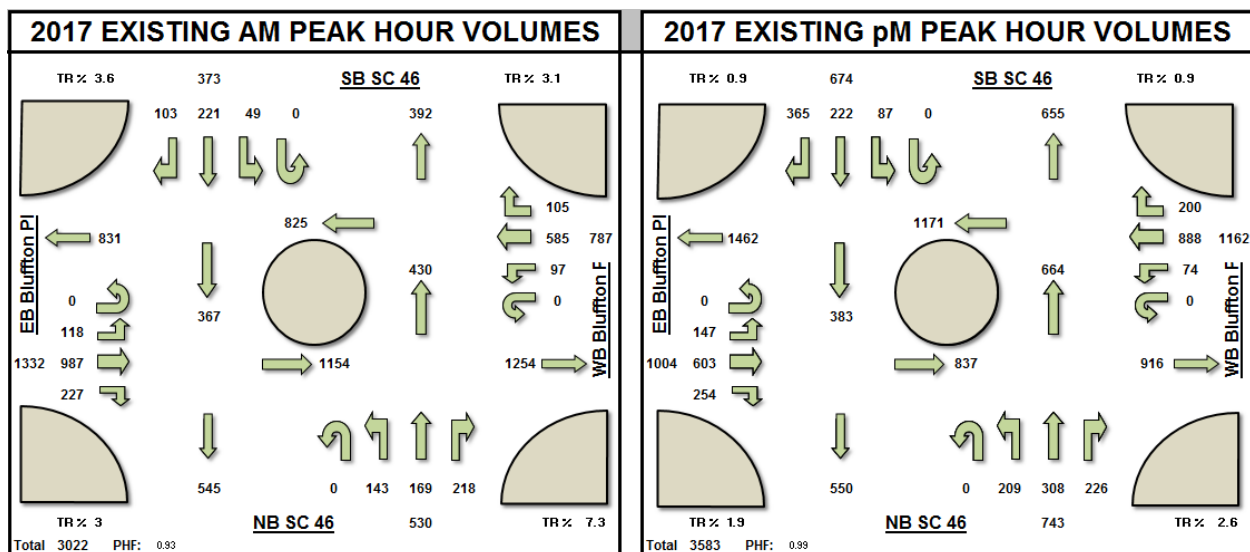
**Figure 1. 2017 Peak Hour Turning Movement Volumes**

The existing roundabout was analyzed in Junctions 9 (ARCADY) roundabout design and capacity analysis software. ARCADY (Assessment of Roundabout Capacity and Delay) is a program based on U.K. empirical research into geometry-capacity relationships. Two features that ARCADY provides are: its ability take into account horizontal geometric design sensitivity and its ability to be calibrated. These two features are critical to accurately modeling the in-service roundabout to determine expected operations for any proposed roundabout geometric modifications. It was determined that a 10% capacity reduction factor was required to calibrate the software to match field observations of queues for the AM and PM peak hours. Turning movement counts conducted by Quality Counts in August 31, 2017 are shown in Figure 1.

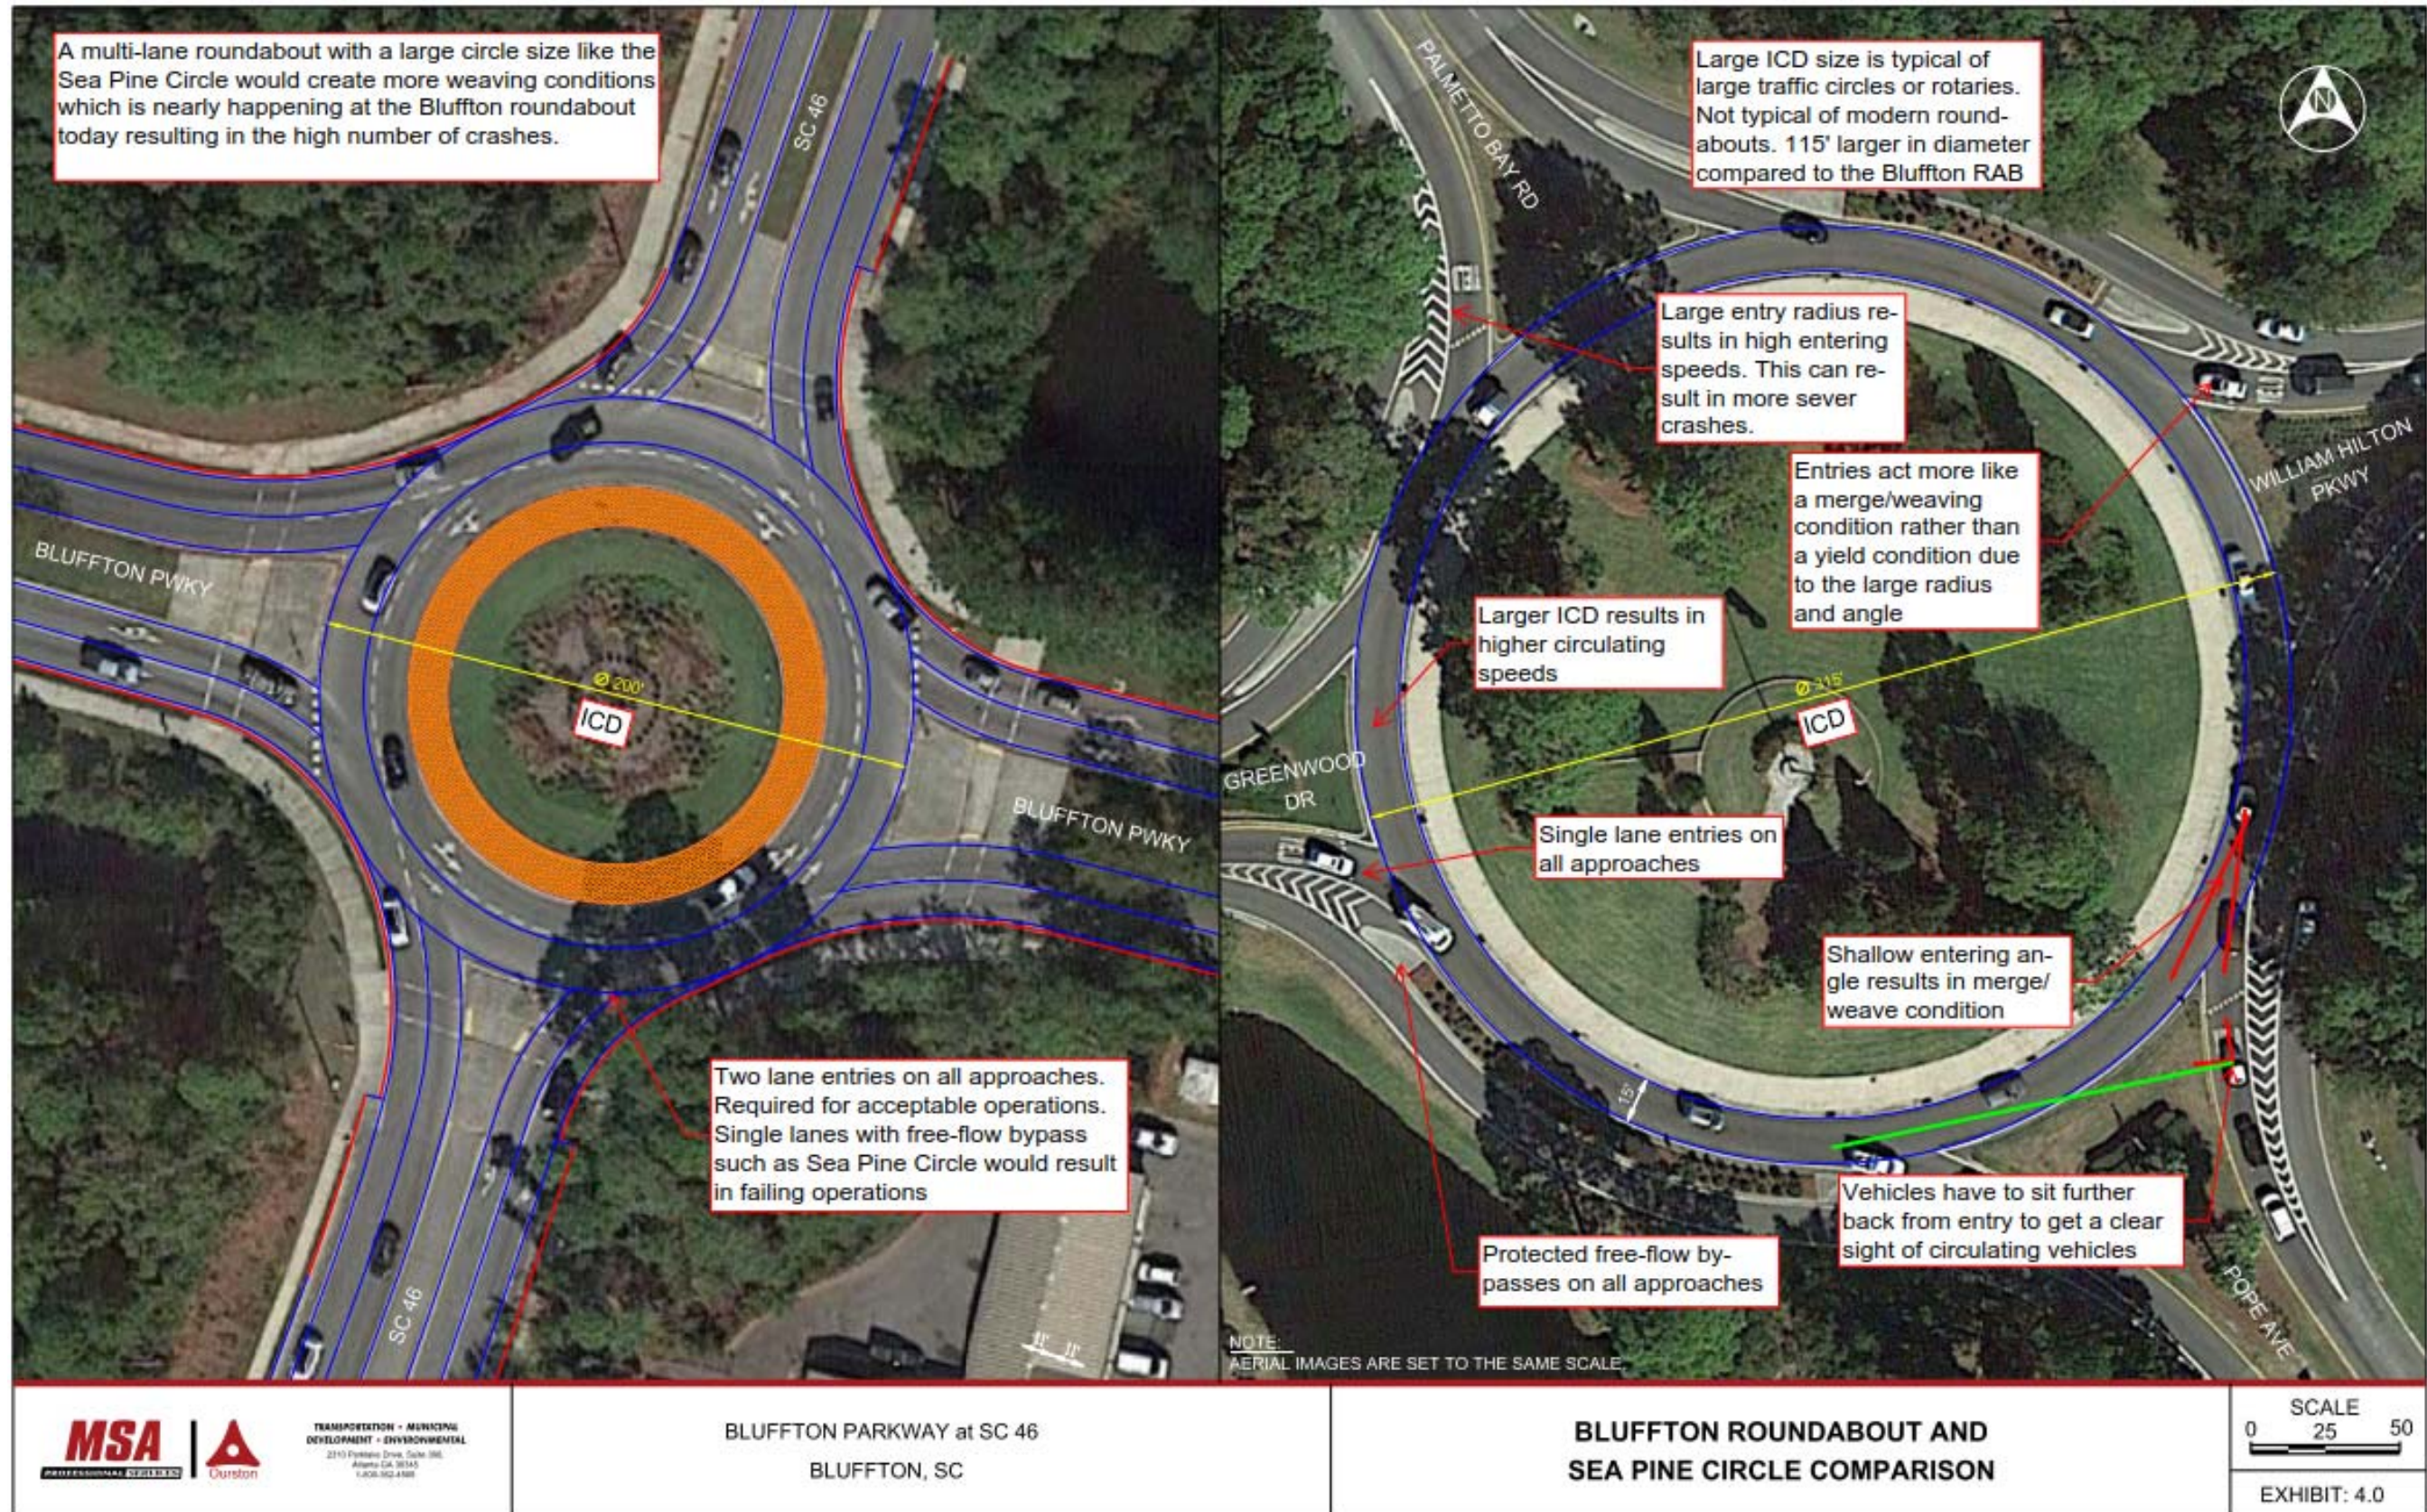
- Drivers had trouble navigating the large conflict area – Drivers had trouble anticipating acceptable gaps to enter
- Poor night time lighting
- No exit guide signs for identification and navigation to downstream destinations
- No overhead lane designation signage for added conspicuity and improved lane choice
- Reduce height of roundabout chevrons on the central island (less than 5ft. is not unreasonable, especially with modern vehicle headlamps)
- Shorten exit stripes, so that the lane line does not need to be crossed by a vehicle on the inside (left) lane and exiting.
- The Sea Pine circle is single-lane with free-flow bypasses on all approaches, much larger
  - Queues stretch more than a quarter mile during peak periods
  - The circle would be crash prone if multi-lane
  - It is not possible to reduce the Bluffton roundabout to single lane due to the higher traffic demands there

Further comparison of the Sea Pine circle to the Bluffton roundabout this shown in Exhibit 4.0

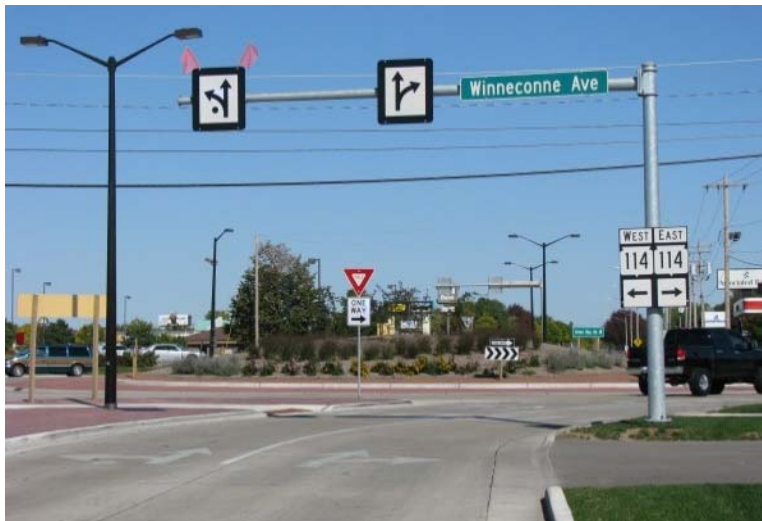
**Figure 2. Overhead Lane Signs**

An alternative low-cost and immediate solution is to enhance approach signing and markings. Enlarged overhead lane designation signs (see Figure 2 and Figure 3) will mitigate some of the circulating roadway sideswipe collisions by promoting correct lane choice on approaches, as well as, promoting yielding to both lanes. Yield signs could also be enhanced with LED indicators to enforce the need to yield on entry, see Figure 5.

Overhead lane designation signs on each approach is still recommended as an immediate improvement, regardless of what geometric design or marking alterations are contemplated now or later. The fish-hook arrow markings should also be replaced with standard arrow markings. These standard arrows are more legible and more widely recognized by drivers.

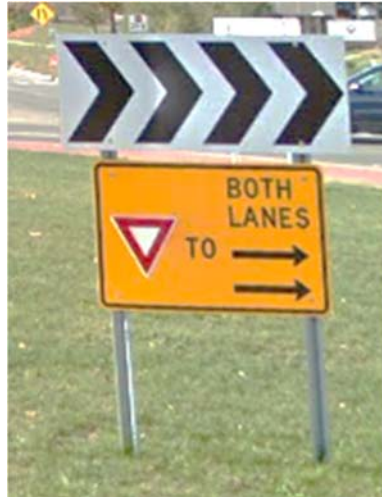
Figure 4. Yield to Both Lanes Sign used in Washtenaw County, MI

Alternatively, Washtenaw County, Michigan has placed a similar sign to Figure 3 in the central island to combat failure to yield crashes at the State Street and Ellsworth Road roundabout, see Figure 4. That sign would require a request to experiment from FHWA (MUTCD).

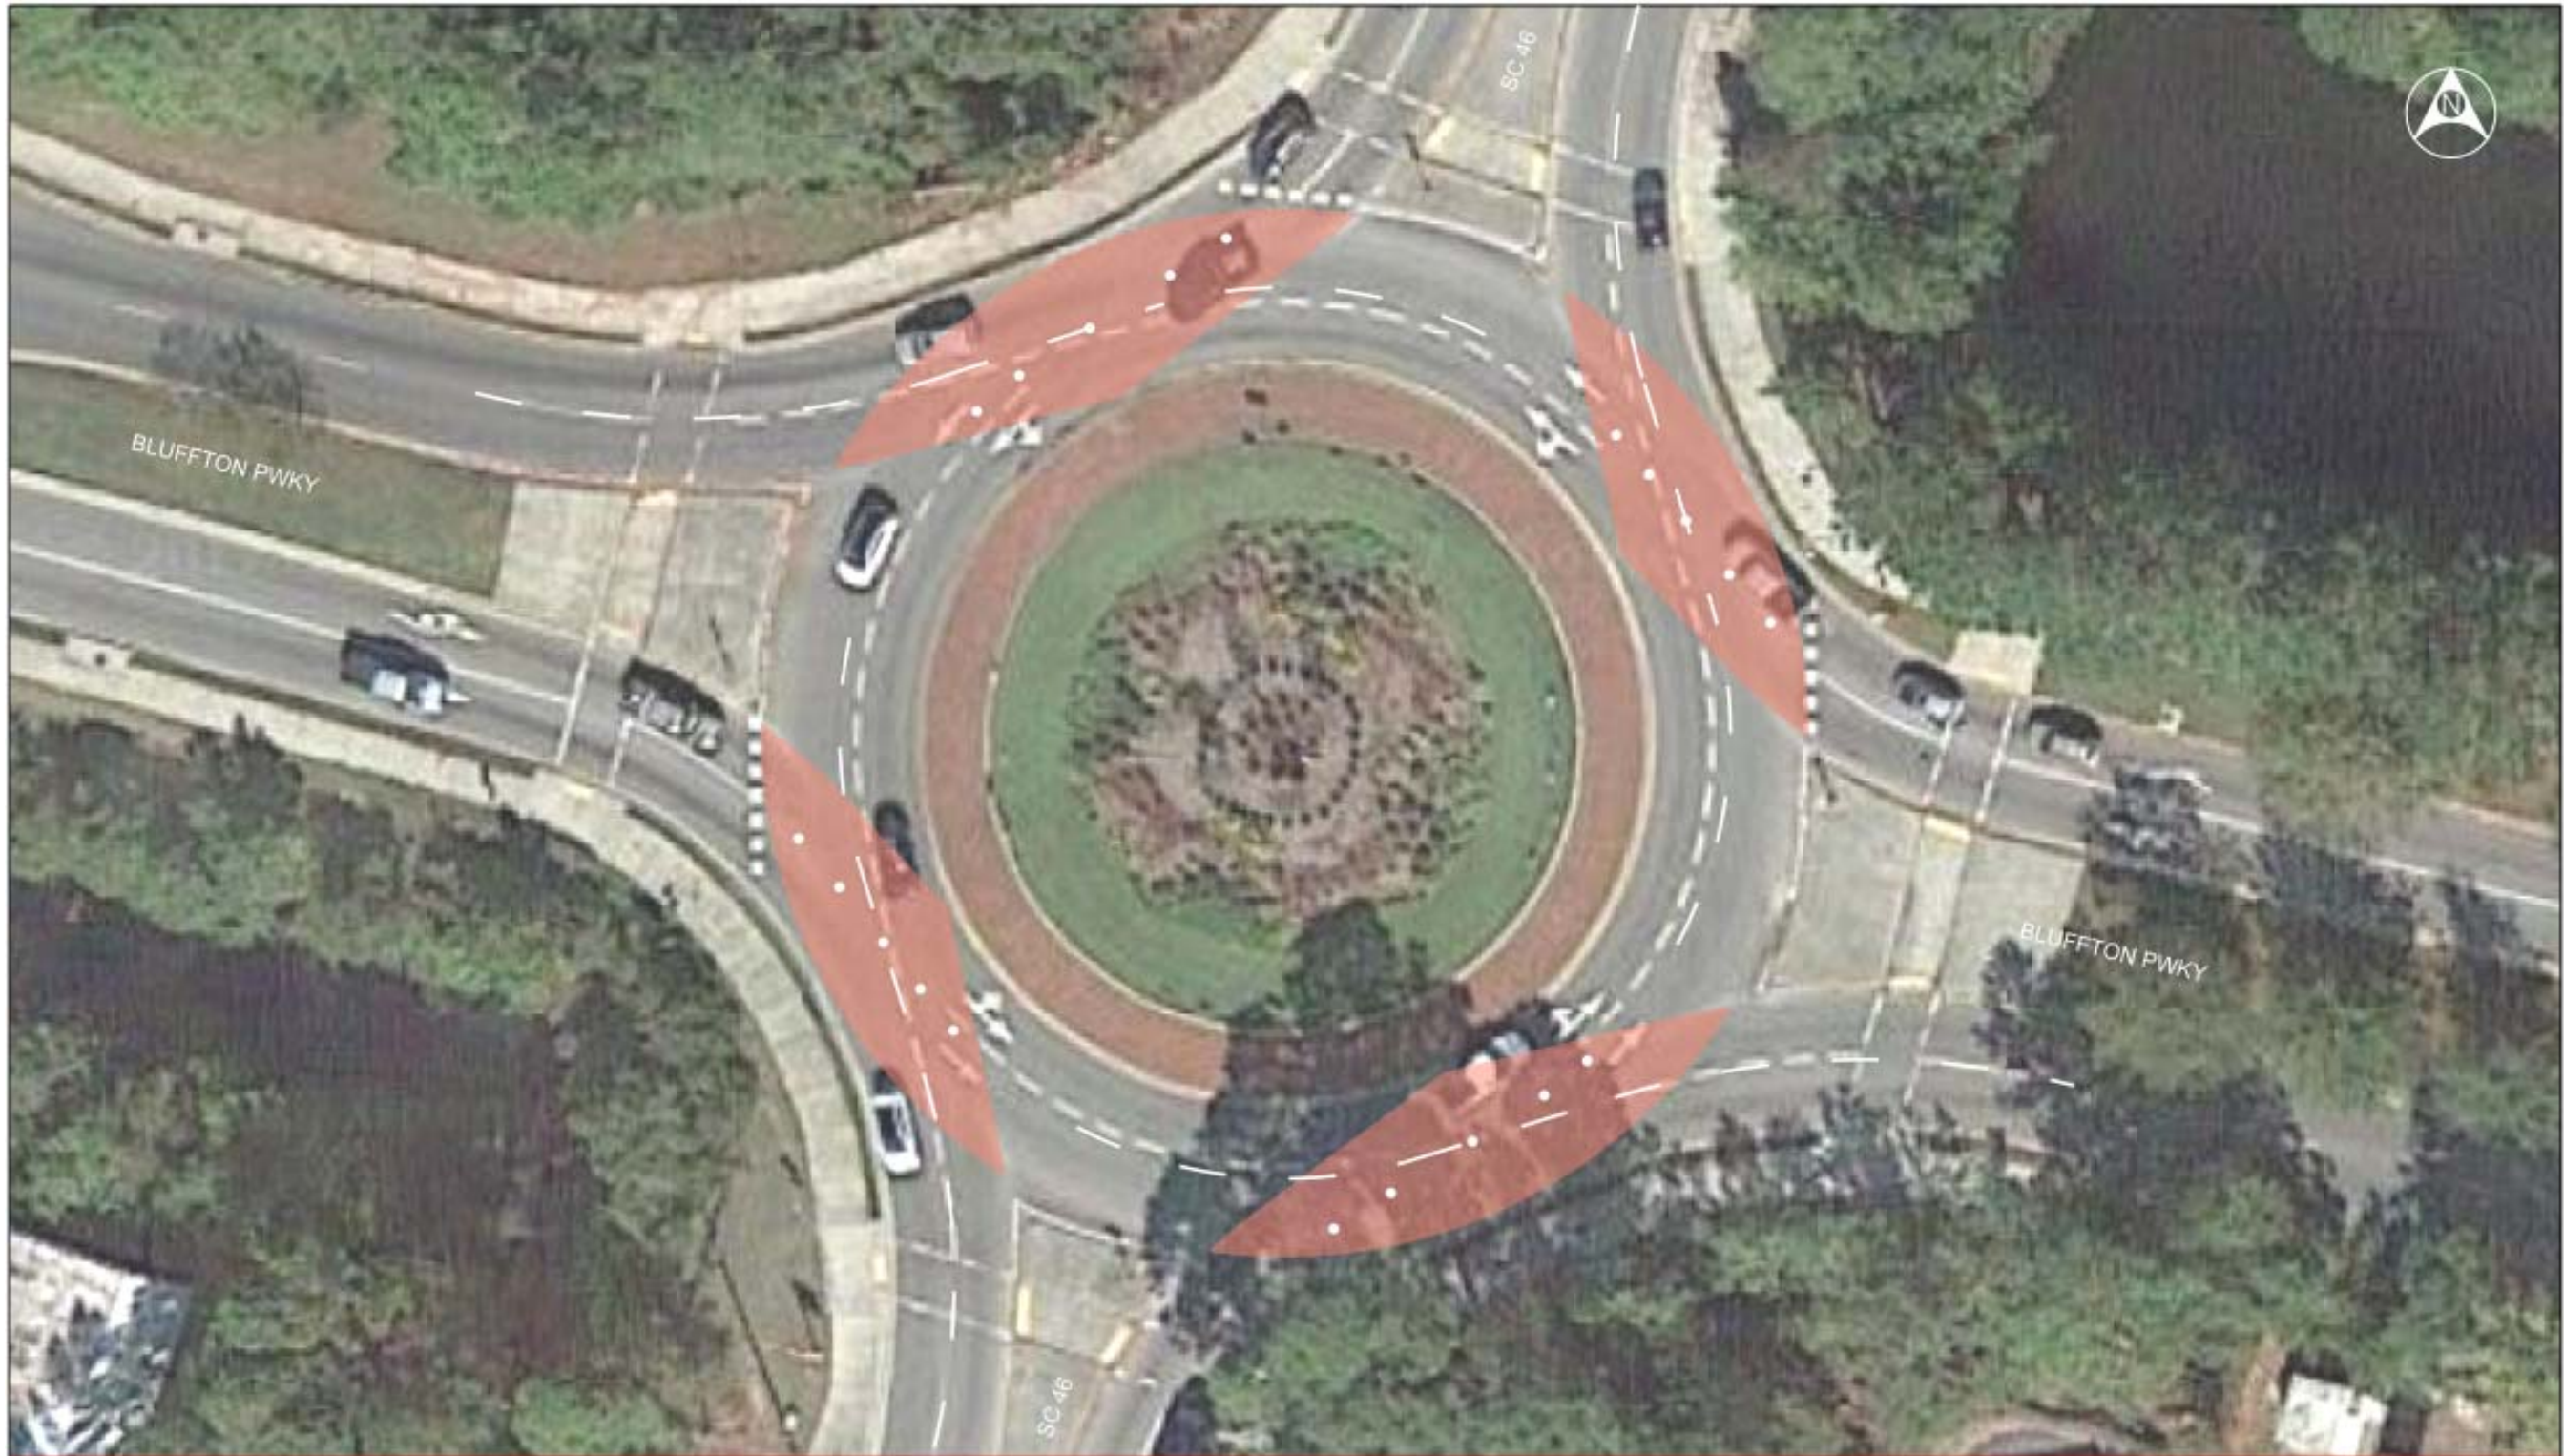
An additional low cost countermeasure would be to apply an epoxy surface coloration to outline the conflict area between entering and circulating vehicles (see Exhibit 5.0) This countermeasure hasn't been applied on any roundabouts to date. Highlighting the conflict area to entering drivers would encourage improved yielding and provide a clear indication of how far the driver has to cross to clear circulating traffic. This countermeasure would involve applying an epoxy surface color to the pavement. A "rusty red" color would then mark the conflict area. It would include re-stripping circulatory lane lines, and adding in entering lane dots to reinforce lane separation on entry. Two companies, Ennis and TransSafe, provide this color pavement marking treatment that uses a slurry type epoxy that is skid resistance, last for 7 plus years, and allows for custom colors. This product is widely used for coloring bike paths across the country and is approved for use on roadways. Product sheets from both companies are attached in Appendix B. Exhibit 5.0 illustrates these modifications on the existing geometry. Based on the following a request to experiment would need to be submitted to FHWA to test this countermeasure since the coloring of the conflict area is a guide/warning to drivers.

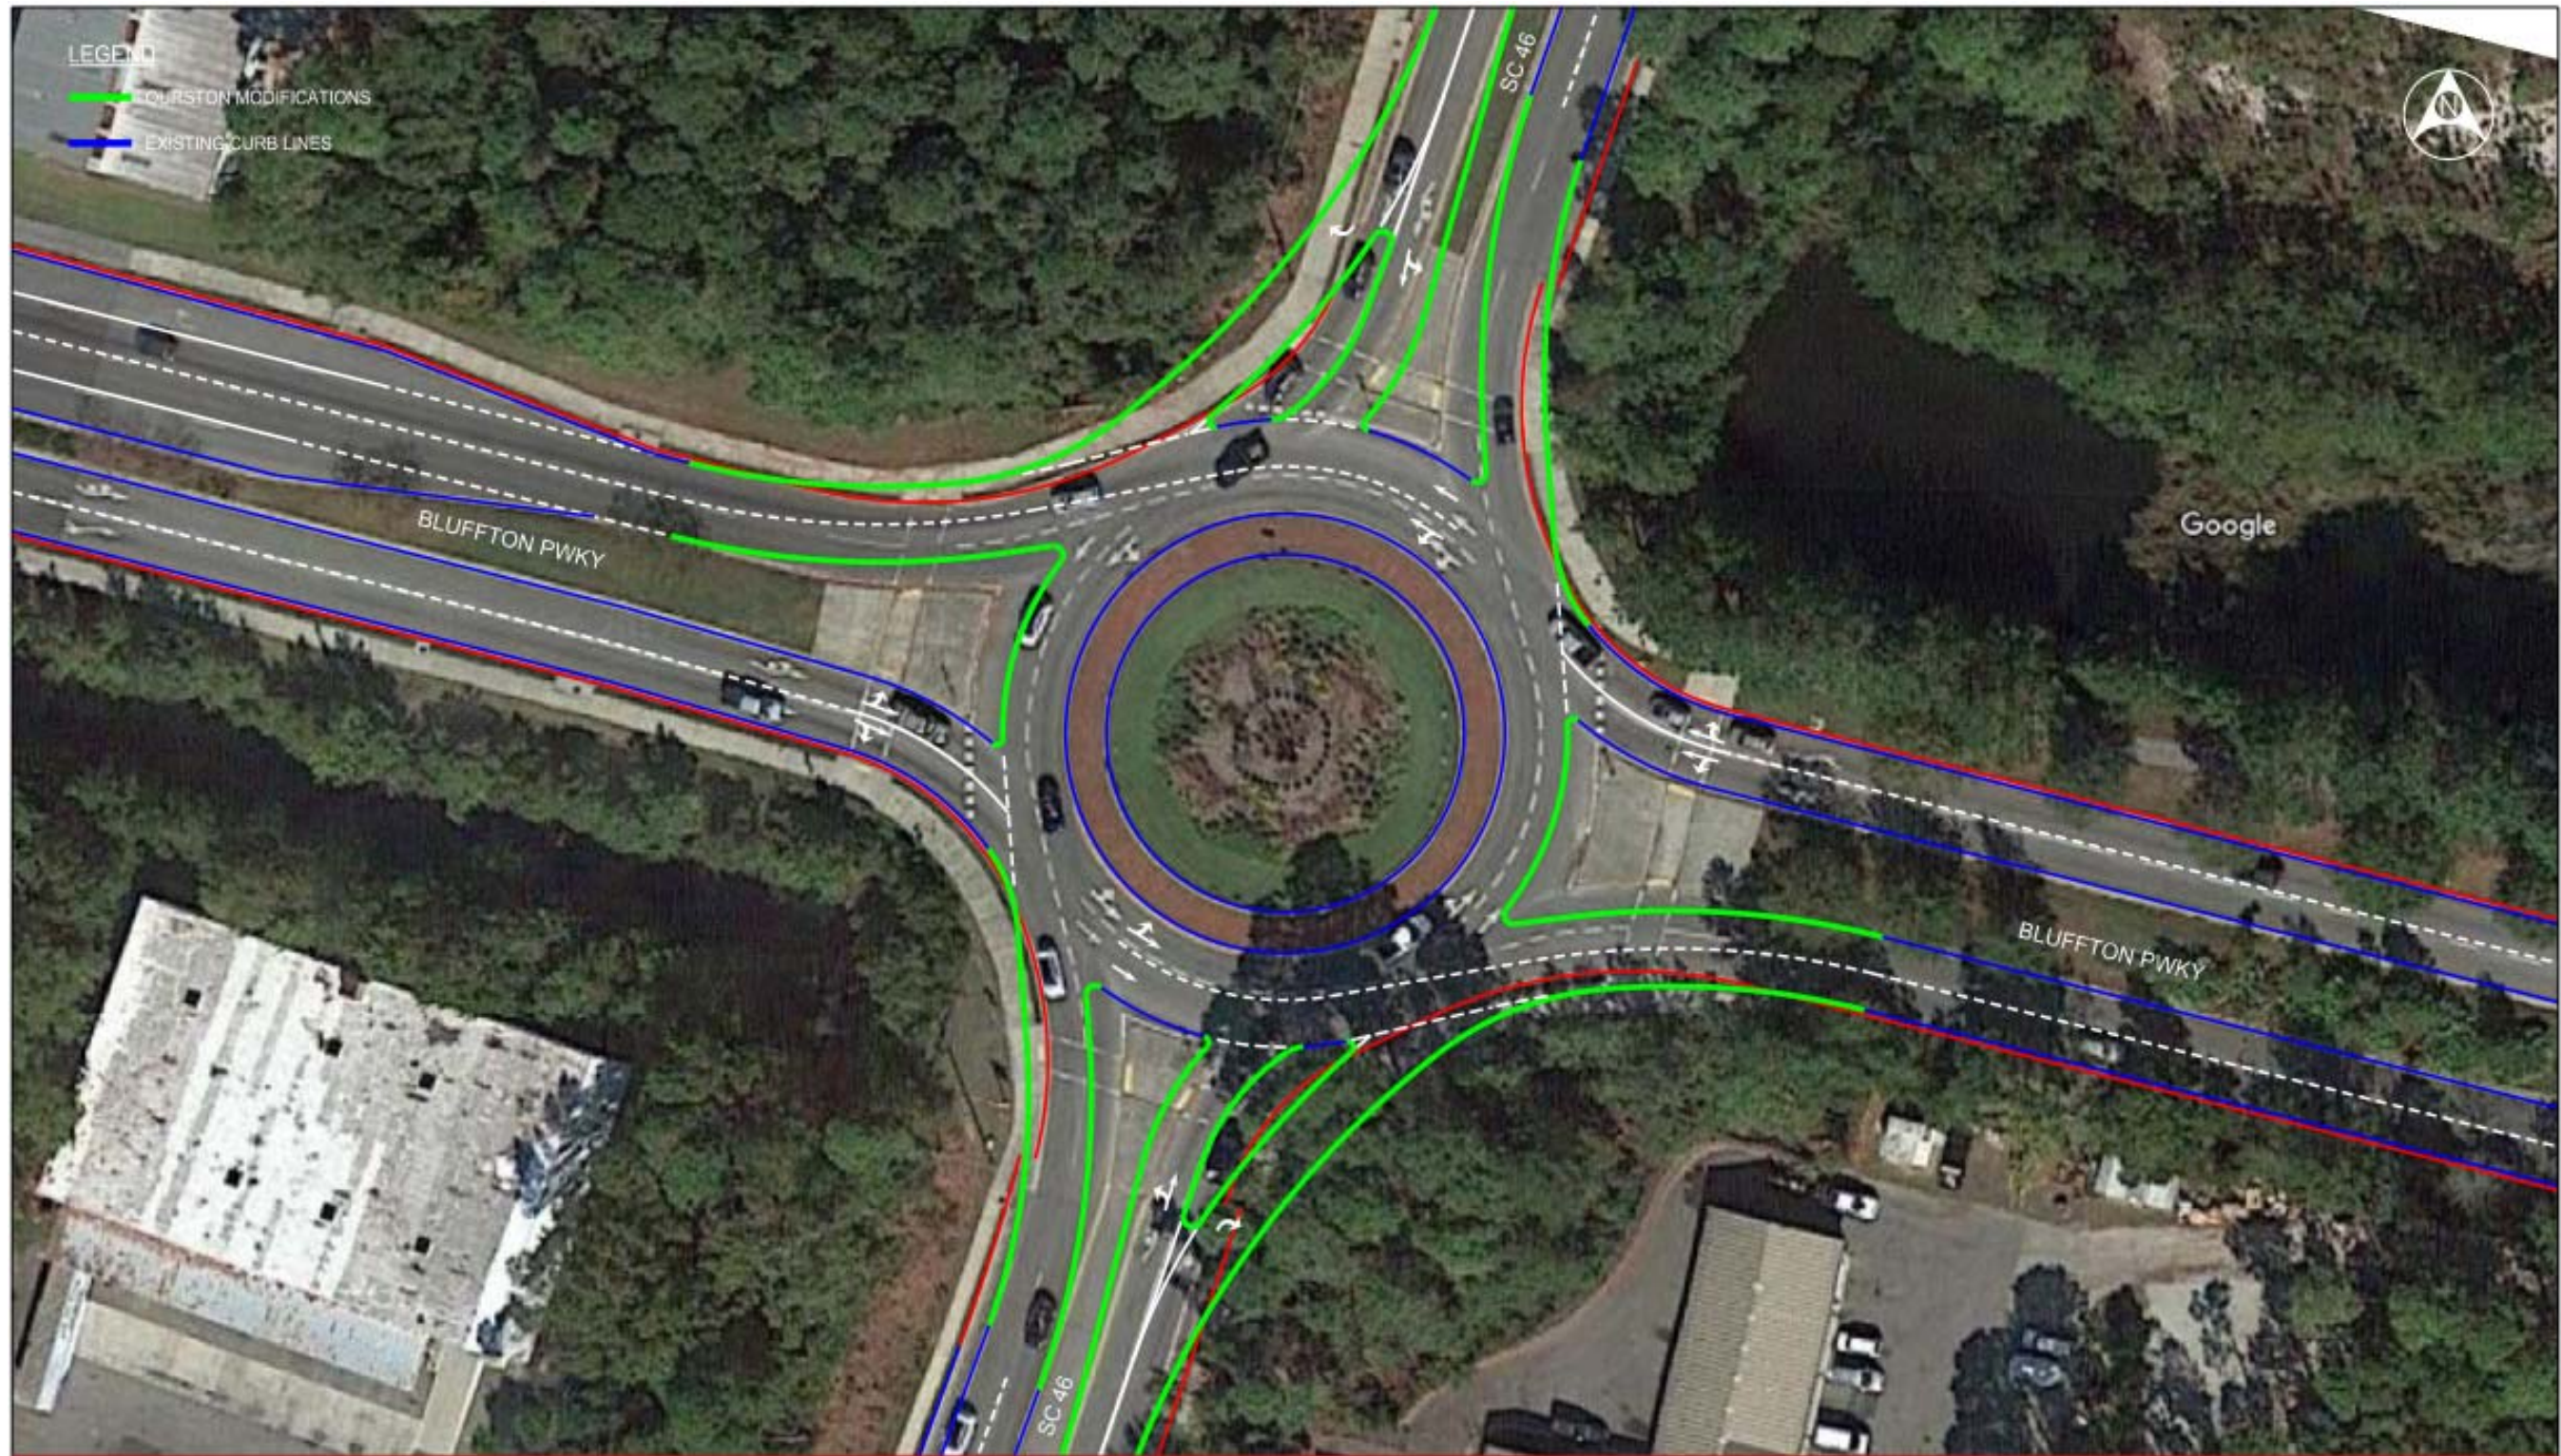
EXHIBIT: 6.0

A reduction in lanes was investigated to reduce the number of conflict points. A 2x1 with northbound and southbound yielding bypasses reduces the number of conflict points in the NW and SE quadrants to half, see Exhibit 6.0. Those quadrants exhibit the highest rate of crashes. The design also incorporates improved exit tangents and gradual exit radii. The reduction in conflict area and conflict points, increased speed control on entry, and improved exit path tangents and radii is expected to reduce the complexity of gap-seeking, the failure-to-yield crashes and improper lane change crashes. A comparison of the current and 2x1 roundabout design conflict areas are shown in Exhibit 7.0.

2x1 DESIGN DIAGRAM

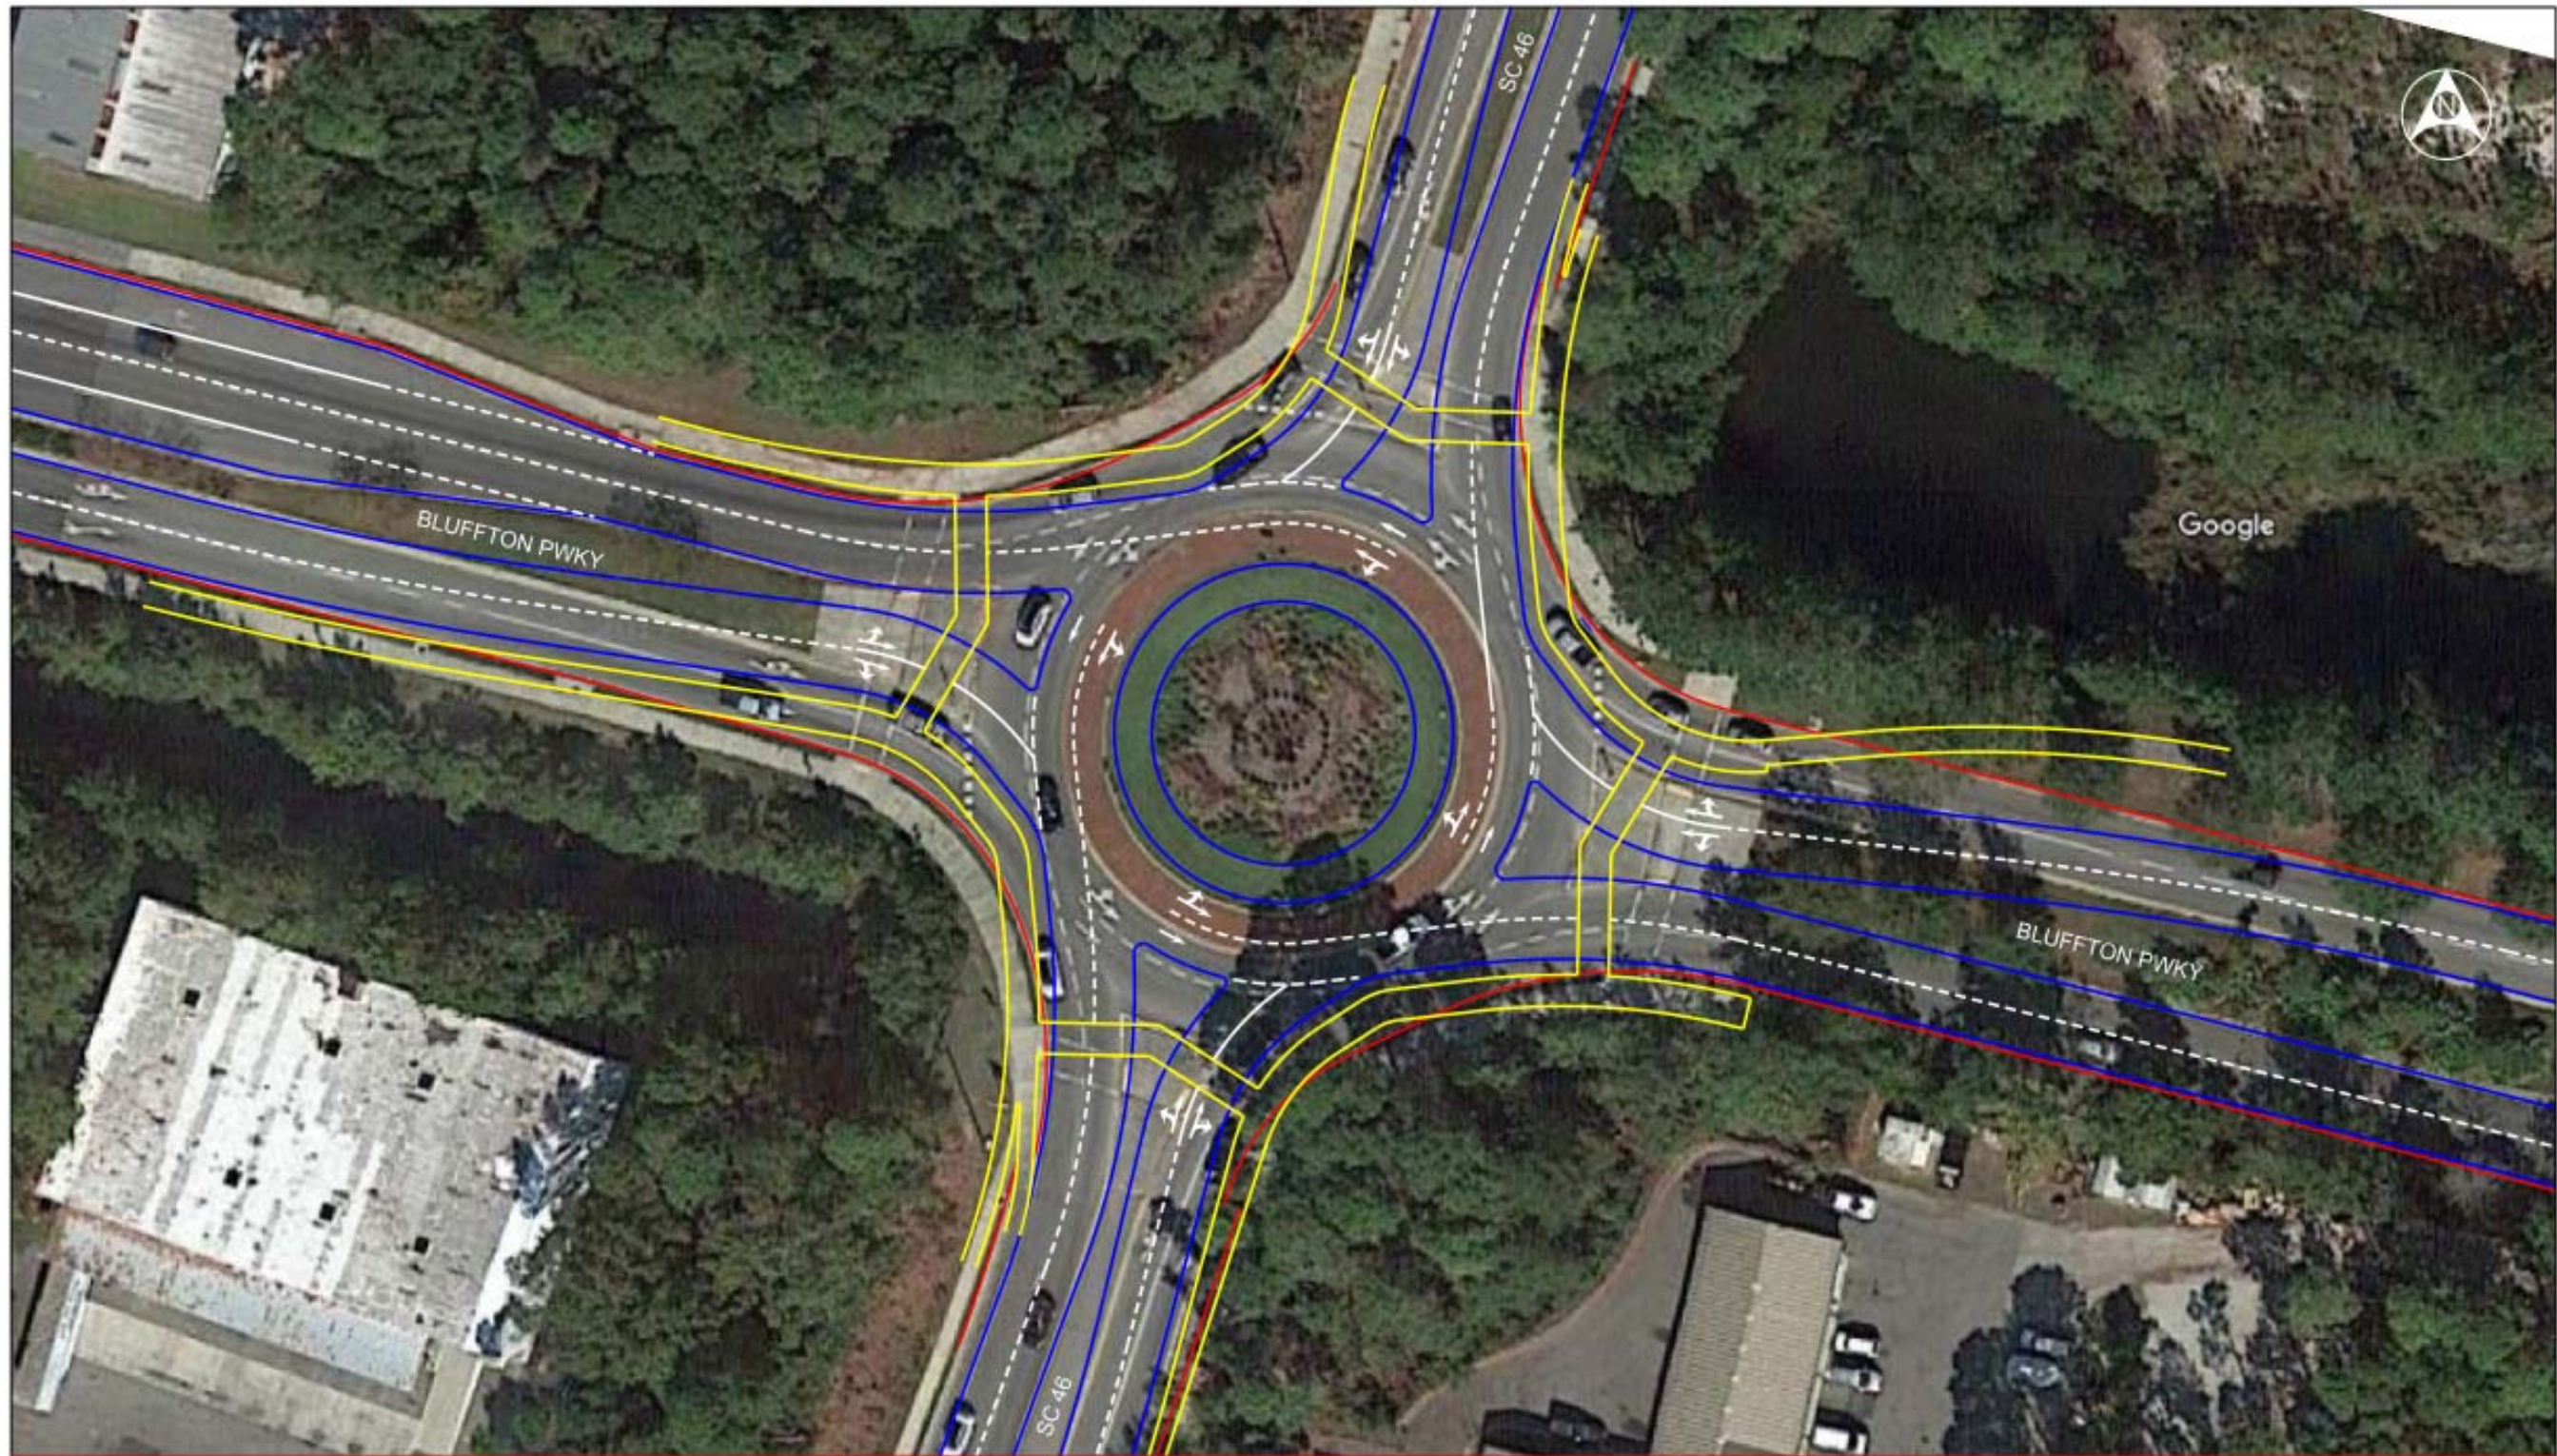
EXHIBIT: 8.0

The rebuild alternative is the highest cost option, but provides the ideal geometric design based on current design standards. The redesigned roundabout is able to fit within the existing curb lines and would not require ROW acquisition for its rebuild, see Exhibit 8.0. The roundabout conforms to present day design practices including an offset-left design, 160' ICD, longer path tangents on entry and exit, entry speeds of 28 MPH or less, and reducing vehicle conflict areas. A comparison of the current and full rebuild roundabout design conflict areas are shown in Exhibit 9.0. As seen in this exhibit, conflict areas and conflict path lengths are reduced, especially the outside lane. Vehicles also travel on a tangent through the conflict area rather than curves currently experience in the existing design. By reducing this conflict area, reduced entry speeds, and longer entry and exit path tangents failure to yield and improper lane change crashes are expected to decrease to within national averages. Further driver education is still strongly encouraged with this countermeasure.

**FULL RE-DESIGN DIAGRAM**
