**To:** Colin Kinton, PE – Beaufort County, SC  
**From:** Mark Lenters – Ourston, and Joe M. Garcia, PE – Ourston  
**Subject:** Bluffton Parkway at Bluffton Road (SC 46)  
Roundabout In-Service Review  
**Date:** February 15, 2018

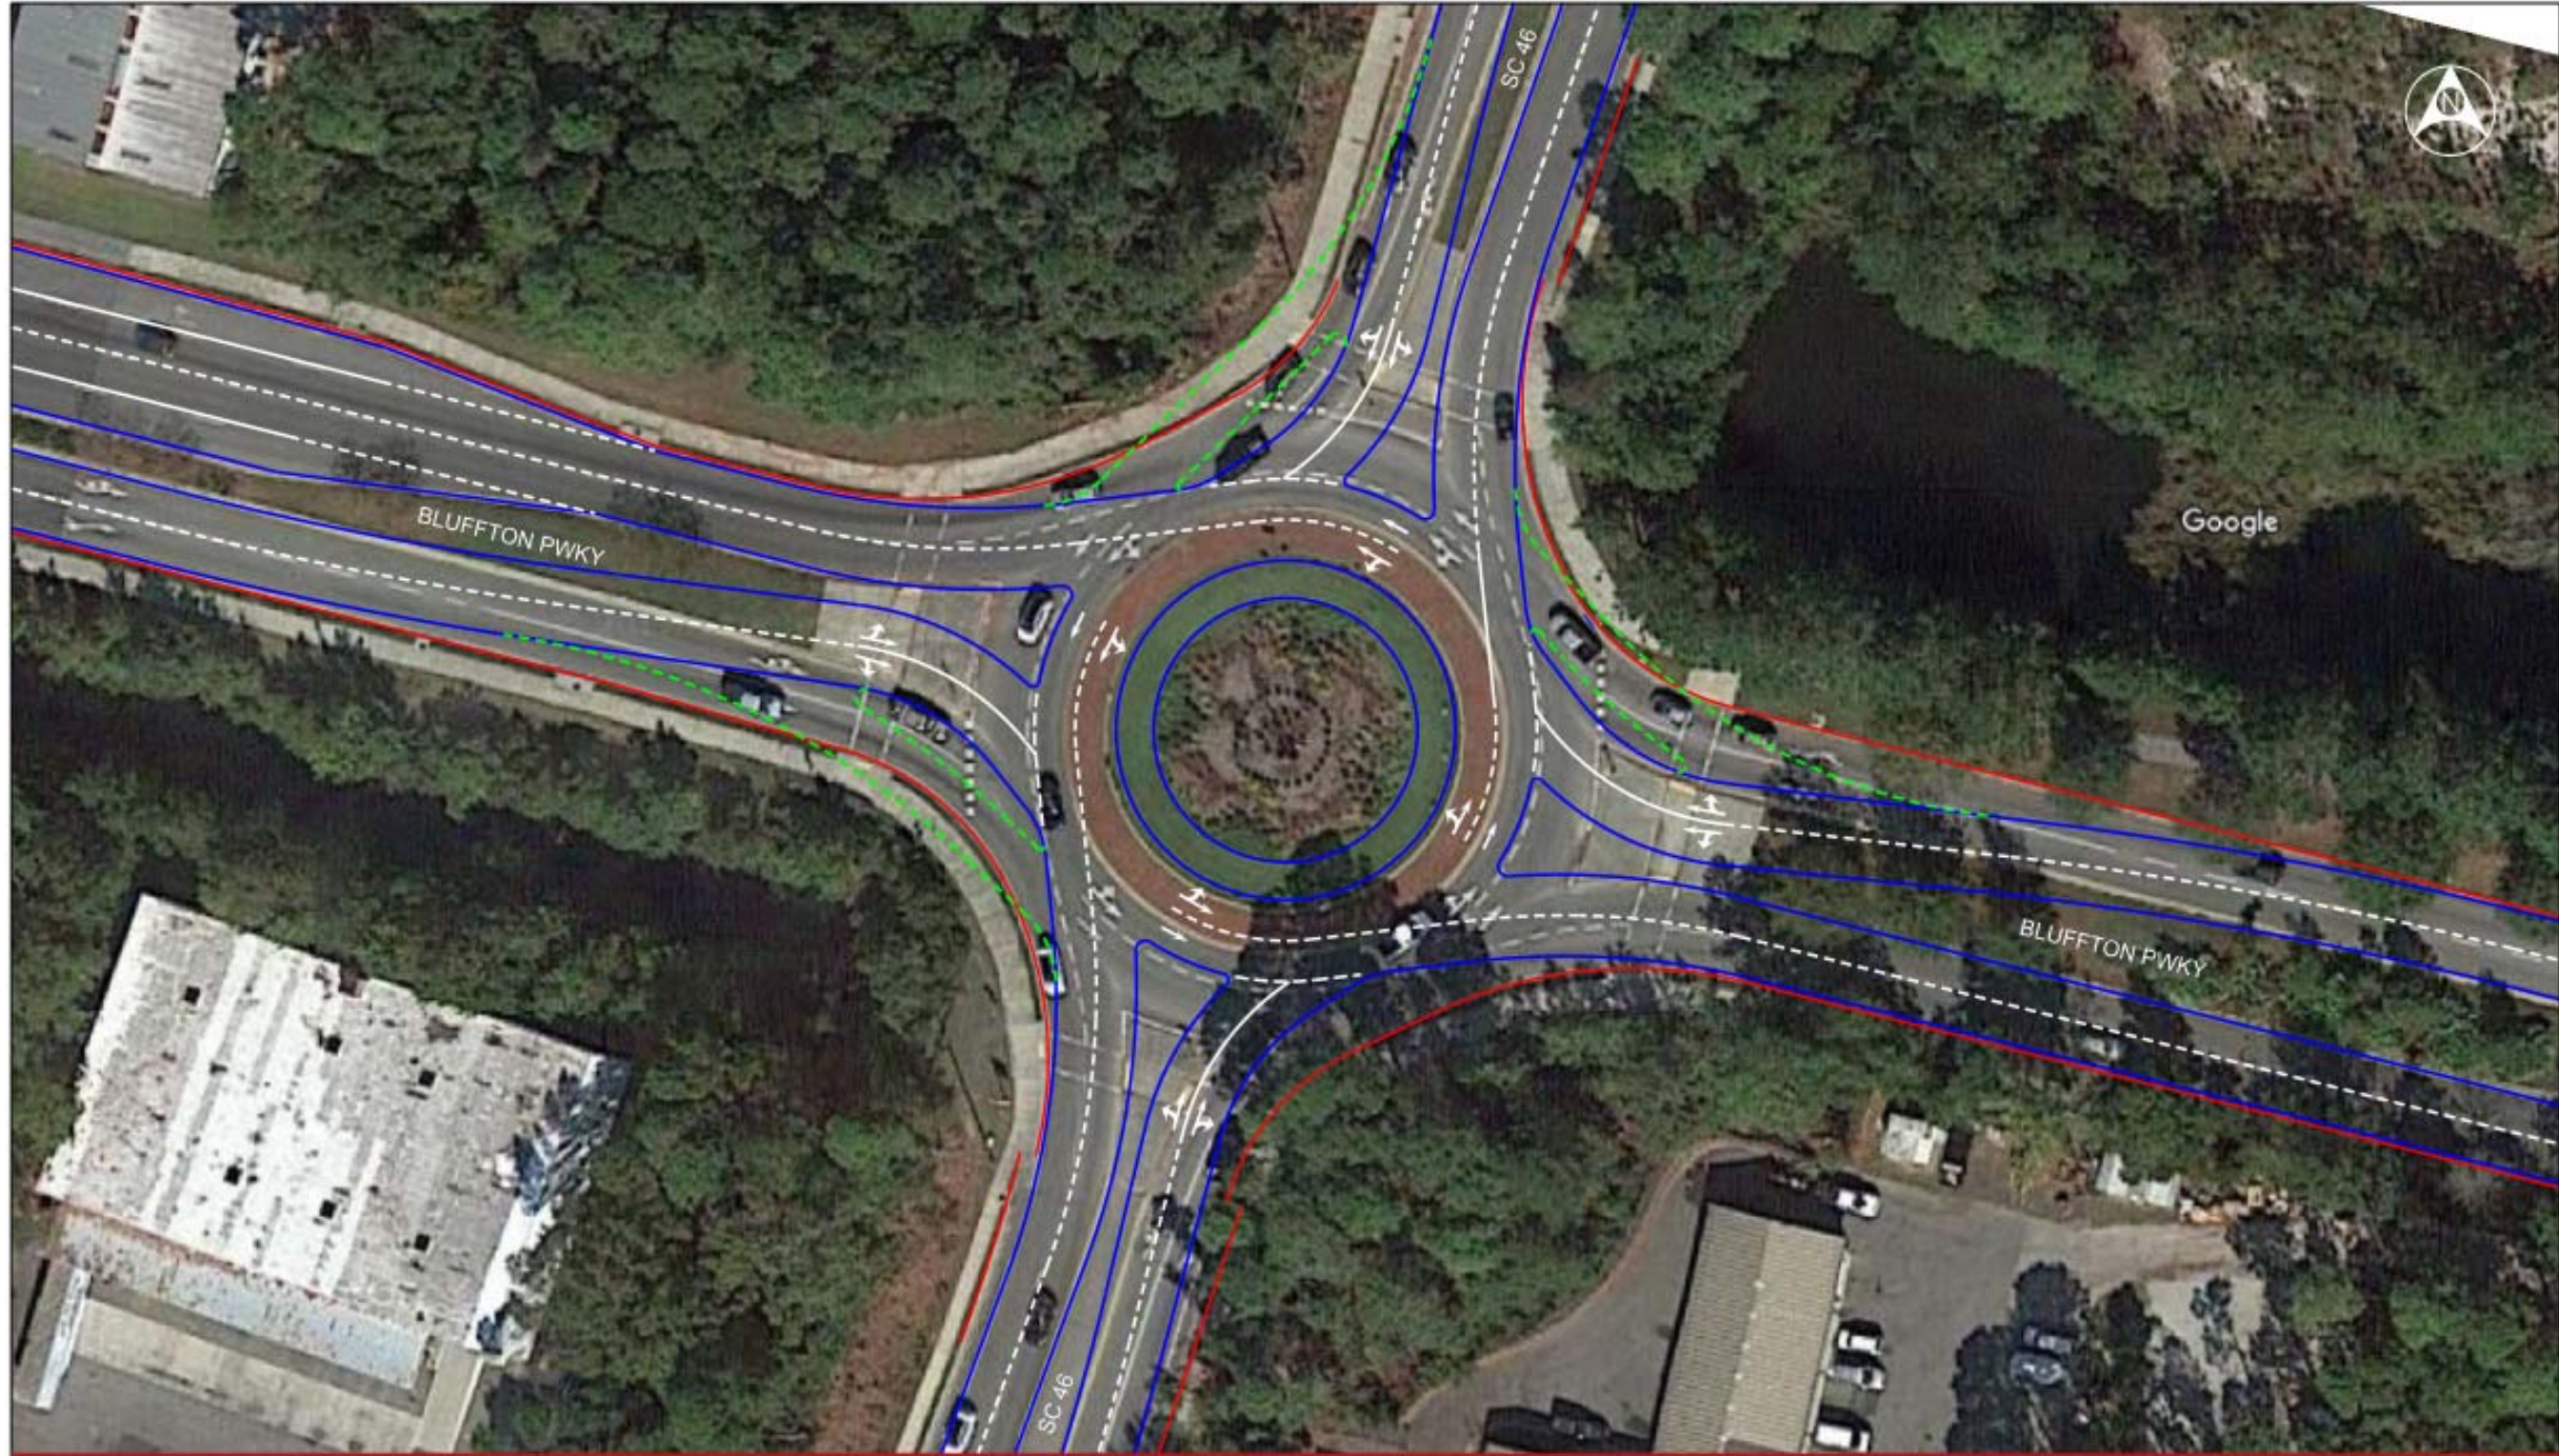
EXHIBIT: 9.0

Additional residual capacity can be achieved by adding right-turn yielding bypasses to the eastbound, westbound, and southbound approaches. By adding bypasses to these approaches an additional 8% residual capacity is gained, resulting in a critical residual capacity of 24% in the AM Peak. At a compounding growth rate of 2% per year the roundabout is expected to operate well for 11 to 13 years, but will begin to experience peak hour delays after 11 years. Detail reports of this analysis are seen in Appendix A. The bypass lanes can be constructed when they are necessary or installed concurrently with the overall reconstruction . A concept layout of the full rebuild with the additional right-turn yielding bypasses are show in Exhibit 9.0.

FULL RE-DESIGN WITH BYPASSES DIAGRAM
