Signal Warrant Analysis

**Bluffton Parkway at Masters
Way/Crossings Blvd.
Beaufort County, SC**

Prepared for:
Beaufort County

**Prepared by:
Bihl Engineering, LLC
12 Park Square North
Beaufort, SC 29907
(843)637-9187**

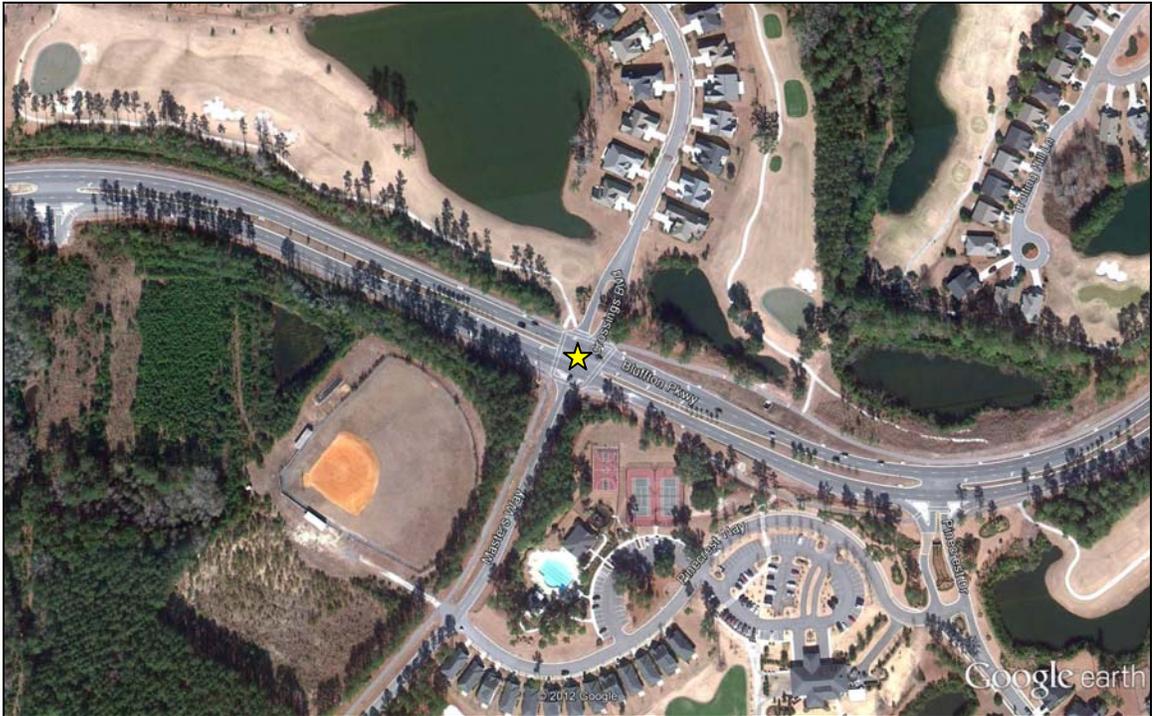
Figure 1: Intersection Location

Figure 1 shows the location of the study area intersection, **Figure 2** shows a zoomed image of the intersection.

Bluffton Parkway is a four-lane roadway with left-turn lanes and a 25-foot planted median in the vicinity of Masters Way/Crossings Blvd. It has a posted speed limit of 45 mph. Approximately 400 feet east of the intersection is a vertical curve, and approximately 1,200 feet west of the intersection is a horizontal curve.

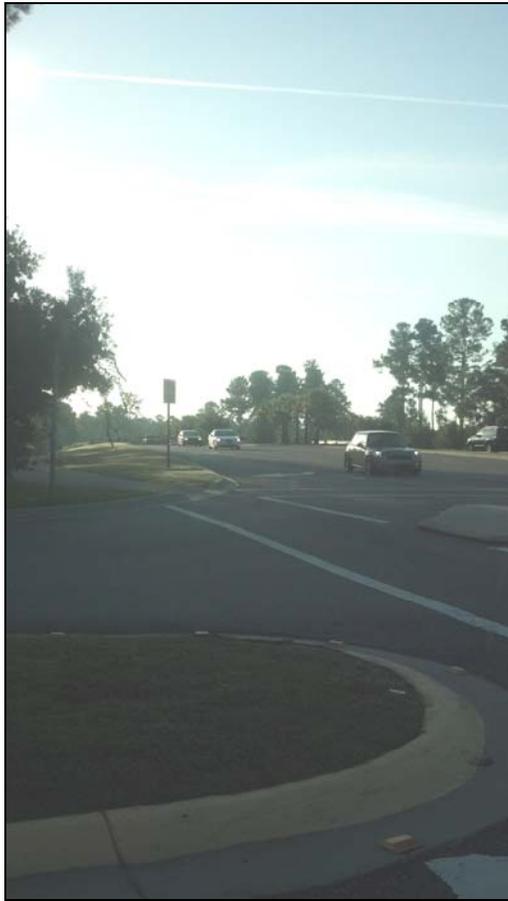
Figure 3: Vertical Curve (from Crossings Blvd.)

Horizontal and vertical curves occur in the vicinity of this intersection. A vertical curve due to a golf cart tunnel occurs approximately 400 feet east of the intersection on Bluffton Parkway (see photo in **Figure 3**). A horizontal curve occurs in the roadway approximately 1,200 feet west of the intersection on Bluffton Parkway (see photo in **Figure 4**).

Stopping sight distance on westbound Bluffton Parkway for vehicles entering the intersection from Crossings Blvd. as well as intersection sight distance from Crossings Blvd. looking eastbound on Bluffton Parkway was measured on the plan/profile sheets for Bluffton Parkway to be approximately 495 feet.

The standard based on the SCDOT Design Manual is 380 feet for 45 mph condition considering a 3% downgrade. Therefore, the SCDOT standard for stopping sight distance is met.

Based on SCDOT Design Manual formulas (Intersection sight distance = $1.47 * \text{Speed} * \text{Gap Acceptance}$), intersection sight distance for a left-turn from Crossings Blvd. to eastbound Bluffton Parkway was calculated to be 598 feet. This assumes a 9.04 second gap acceptance based on SCDOT gap acceptance formulas assuming the turn will be performed in one maneuver. Assuming a two-step maneuver, the intersection sight distance was calculated to be 529 feet with an 8 second gap acceptance. During field observations, there was approximately a 7 – 9 second gap in the westbound vehicles. Based on the results of the analysis, it is recommended that the speed limit in this section be reduced to 35 mph where the intersection sight distance required is 465 feet.

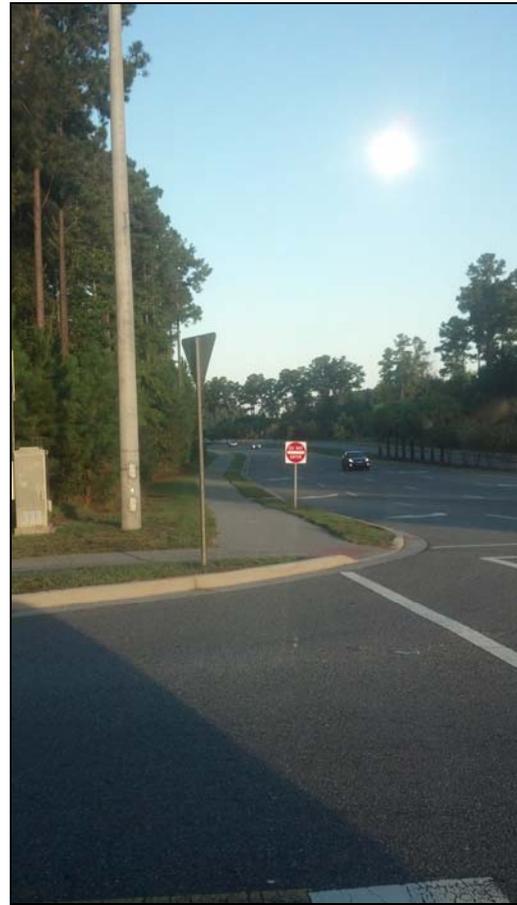
Figure 4: Horizontal Curve (from Masters Way)

It is noted that the County should check the height of the “Do Not Enter” sign as it appears to be mounted low and may obstruct the view of the turning drivers until they proceed past the sign (see **Figure 4**).

Horizontal curve sight distance appears to be sufficient. There is approximately 1,200 feet between the intersection and the horizontal curve.
