BEAUFORT COUNTY  
STORMWATER MANAGEMENT UTILITY BOARD AGENDA  
Wednesday, February 24, 2016  
2:00 p.m.  
Executive Conference Room 170, 100 Ribaut Road, Beaufort, SC  
843.255.2805

- C. Presentation of the Plantation Business Park Storm Sewer Assessment Report – Eric Larson, P.E. ([backup](#))
6. NEW BUSINESS
7. PUBLIC COMMENT
8. NEXT MEETING AGENDA

## Beaufort County Stormwater Management Utility Board (SWMU Board) Meeting Minutes

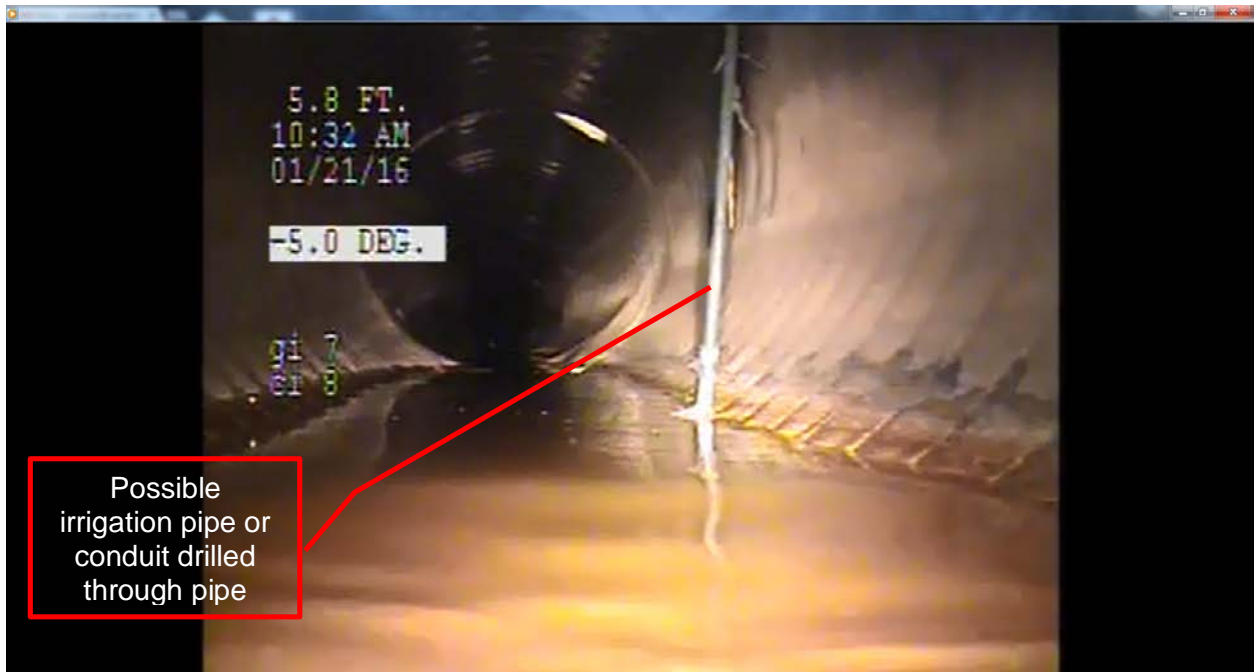
G17-G18 HDPE Pipe: This pipe is in very poor condition. There appears to be some sort of small utility (irrigation or electrical conduit) pipe drilled through the storm pipe. Severe deflection is occurring within some sections of the pipe, resulting in large, visible cracks in the inner wall. Deflection is also occurring at some joints, with noticeable gaps in the inner walls. There are frequent buckling occurring along the entire length, making the invert of the pipe uneven along the length. This would result in flow restriction within the pipe. Visual estimation of the deflection shows typical vertical deflections around 2" (8%), exceeding the maximum allowed 7.5% deflection. Per SCDOT inspection requirements, pipes with greater than 7.5% of deflection require removal and replacement. Significant root intrusion is occurring within multiple portions of the pipe. These conditions indicate improper handling and installation of the pipe during construction and likely would not be a result of long term settlement or poor maintenance.

Figure 11: Pipe GI7-GI8: Irrigation pipe or electrical conduit drilled through pipe.

- The conditions of all of the HDPE pipe sections are so poor that they likely require removal and replacement. Given that the HDPE pipe is located within landscape areas and within drainage easements; excavation, removal, and replacement with new RCP is likely the best option.

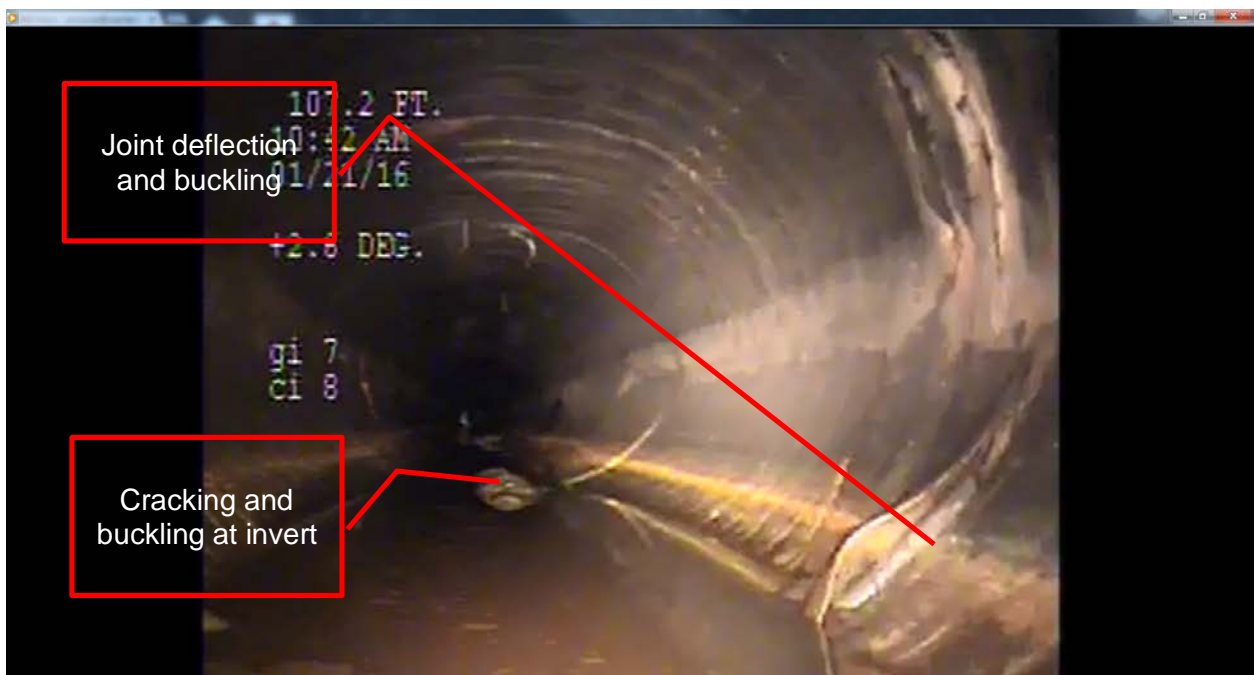
Figure 12: Pipe GI7-GI8: Joint damage likely from improper installation.
