Beaufort County Public Works Stormwater Infrastructure Project Summary

Project Summary: DSS Parking Lot

Project #:
2013-515

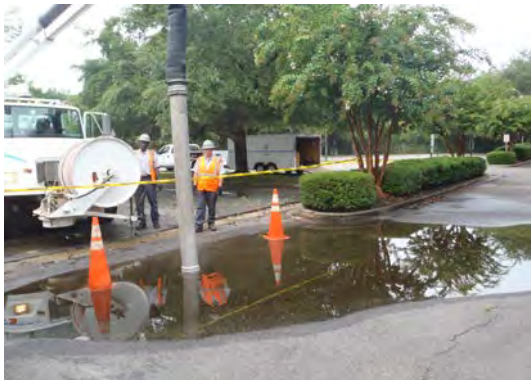
Before

Removed asphalt to repair (2) catch basins, separated joints and recompactd sinkhole. Jetted 92 L.F. of outfall pipe. Resurfaced constructed area.

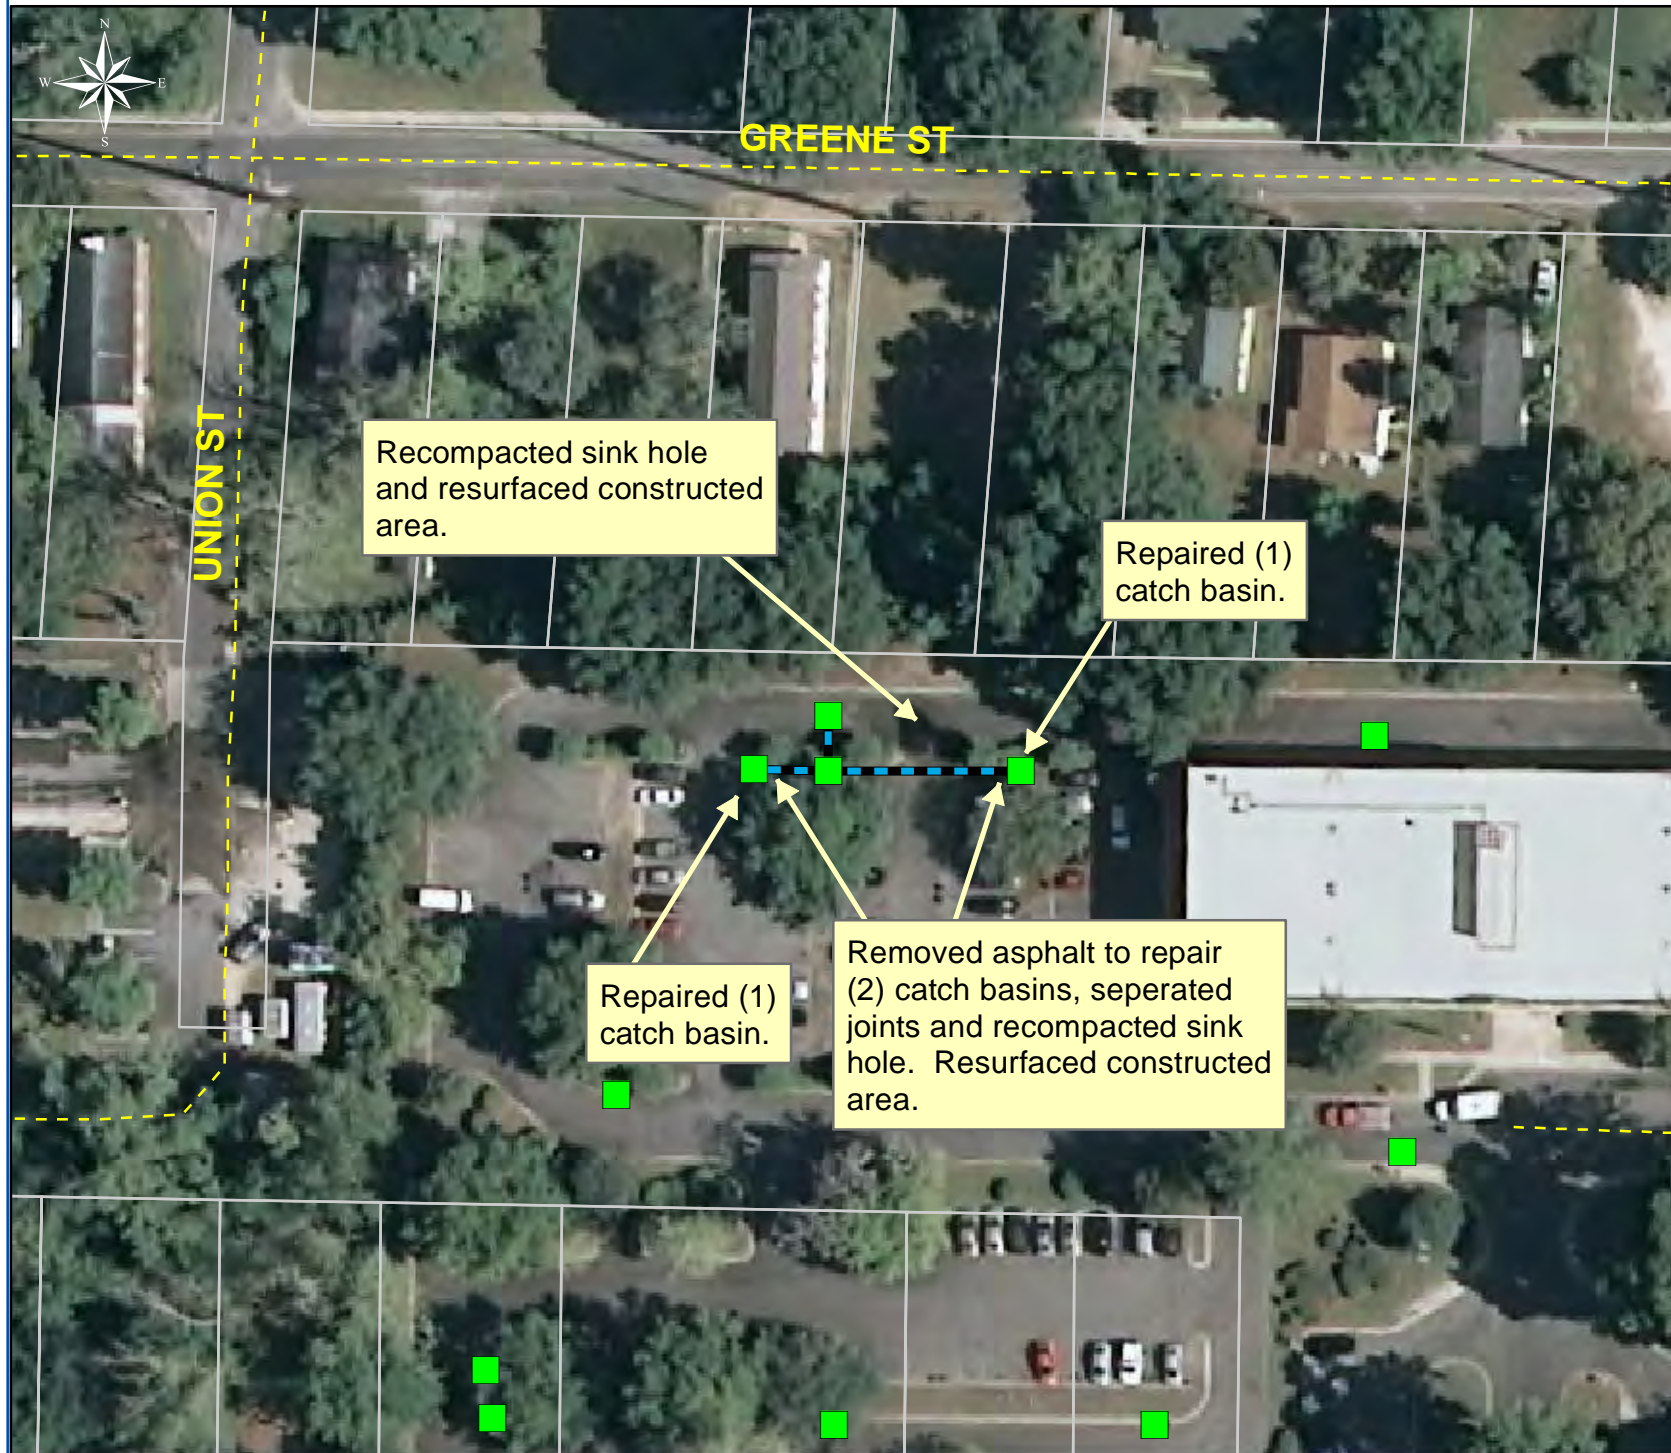
Project: DSS
Parking Lot Map 1

Activity: Vacuum
Truck

Completed:
August 2012
